**RE: MASTERS HOUSE THE OLD LEPER HOSPITAL SALTISFORD WARWICK
URGENT WORKS NOTICE
SECTION 54 PLANNING (LISTED BUILDINGS AND CONSERVATION AREAS)
ACT 1990**

URGENT WORKS NOTICE IN RESPECT OF THE MASTER'S HOUSE, PART OF THE
LEPER HOSPITAL, SALTISFORD, WARWICK, CV34 4TT

**MASTERS HOUSE, SALTISFORD, WARWICK.
Structural Assessment.**

**The Master's House
Saltisford, Warwick CV34 4TT**

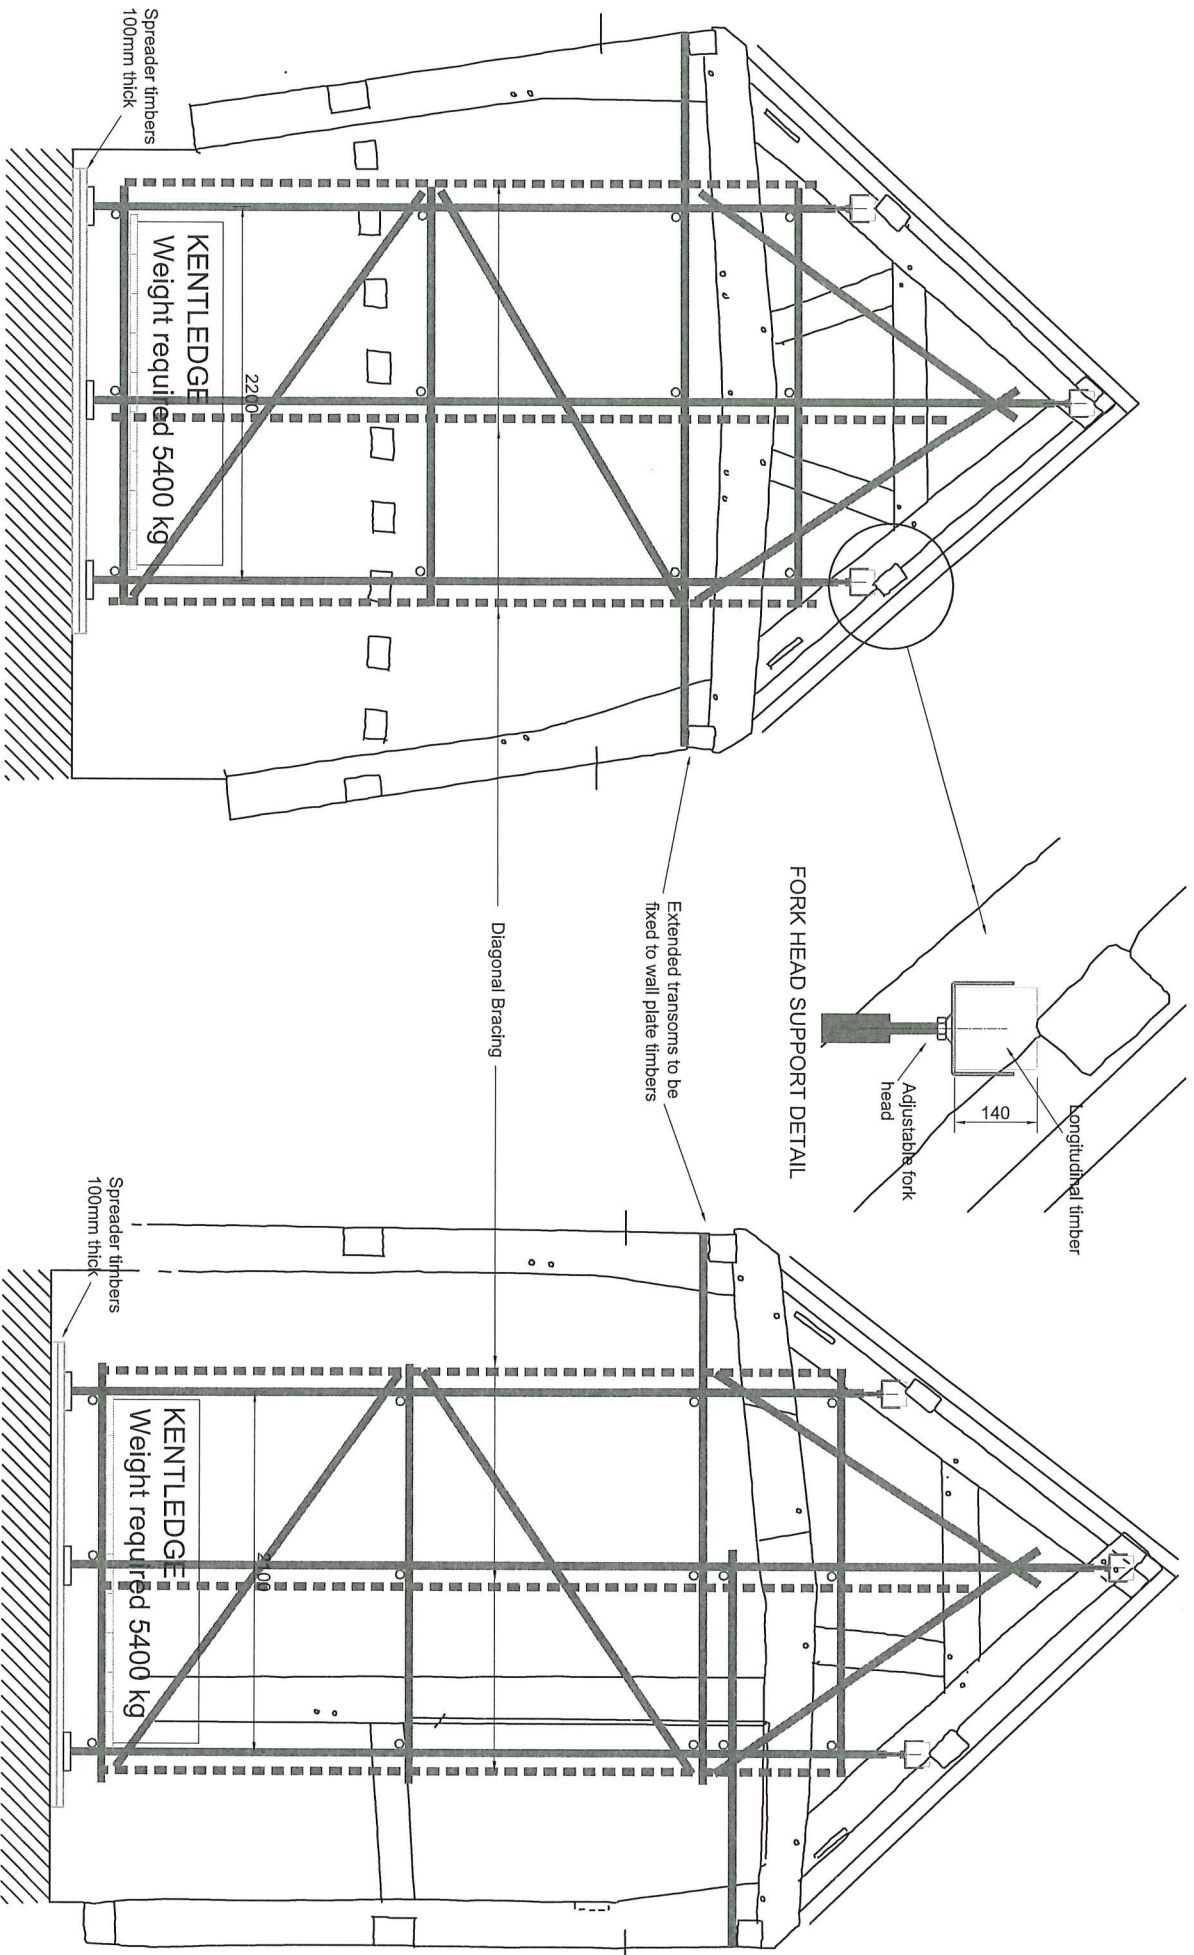
SECTION A-A Scale 1:33 $\frac{1}{3}$

2.3.3 The south west wall of Bay 3 has buckled outwards as there is no lateral tie at mid height.

- 3.5 Bay 3 is judged to be relatively stable laterally so scaffolding is not required but some form of stabilization of the buckled south west wall is required. A pair of steel soldiers from ground level up to the wall plate is recommended, secured to the mid height timber rails.

1.4 The first two can be provided using an internal scaffolding structure together with kentledge. It is not permissible to use ground anchors in view of the possible archaeology below ground. The proposed scheme is shown on drawings 16325/03 A and 16325/04 A.

2.1 **Bay 1.** Work should commence in this bay. The ground should be levelled carefully, tamped and timbers to support the scaffolding laid down. Existing first floor planks to be removed where necessary to permit erection of standards and bracing. The scaffolding can then be fully erected up to purlins and ridge tree and fork head reveals added with timber packers, all as shown on drawings. Fork heads to be screwed up to take up slack and then given a quarter turn to take load. Kentledge can then be loaded onto the lowest platform using concrete blocks or water butts. Kentledge required is 5400kg. Extended transoms to be fixed to wall plates both sides of the scaffolding.

2.2 **Bay 2.** Prepare ground as Bay 1 and lay down spreading timbers. The layout of the new scaffold is intended to avoid the existing scaffolding as much as possible but some minor modifications may be required. The scaffold boards will have to be removed in some cases

to erect the standards etc. The scaffolding can then be fully erected up to purlins and ridge tree and fork head reveals added with timber packers, all as shown on drawings. Fork heads to be screwed up to take up slack and then given a quarter turn to take load. Kentledge can then be loaded onto the lowest platform using concrete blocks. Kentledge required is 5400 kg. Extended transoms to be fixed to wall plates both sides of the scaffolding.
