Our Ref: M45320-JNP-XX-XX-L-S-0001-P02/GS

Warwick District Council

Re: Linen Street Carpark – Initial Structural Condition Appraisal - P02 Issue

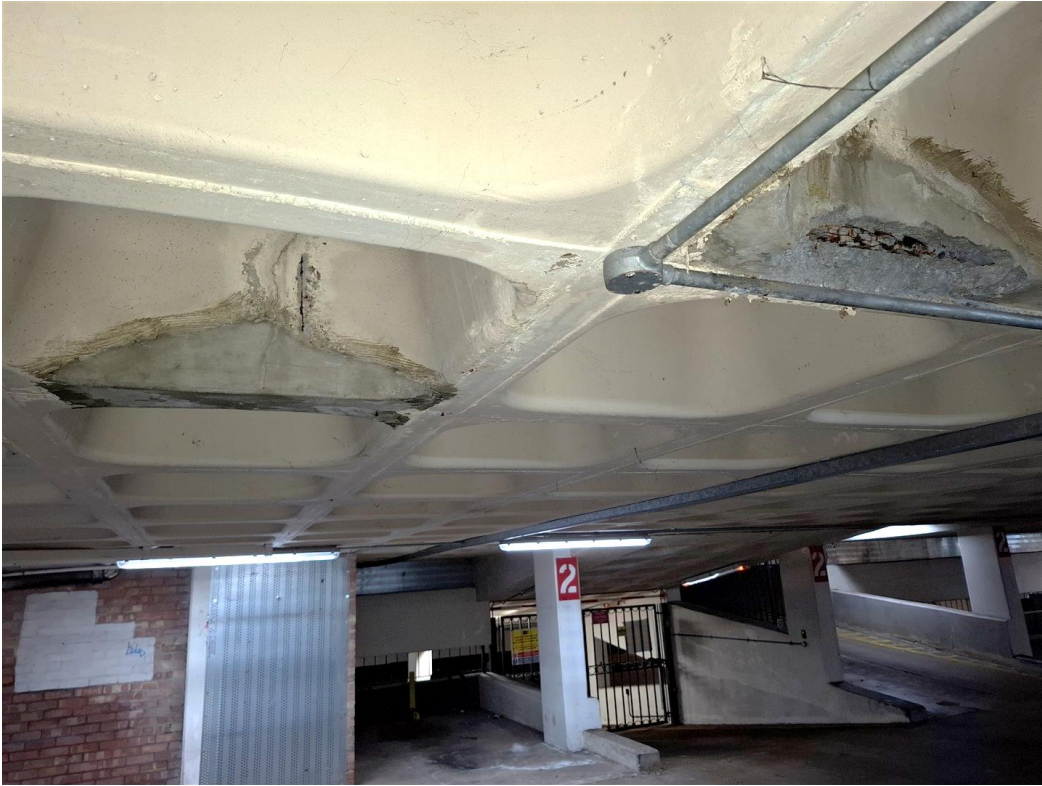
Photograph 1 – Previous repairs

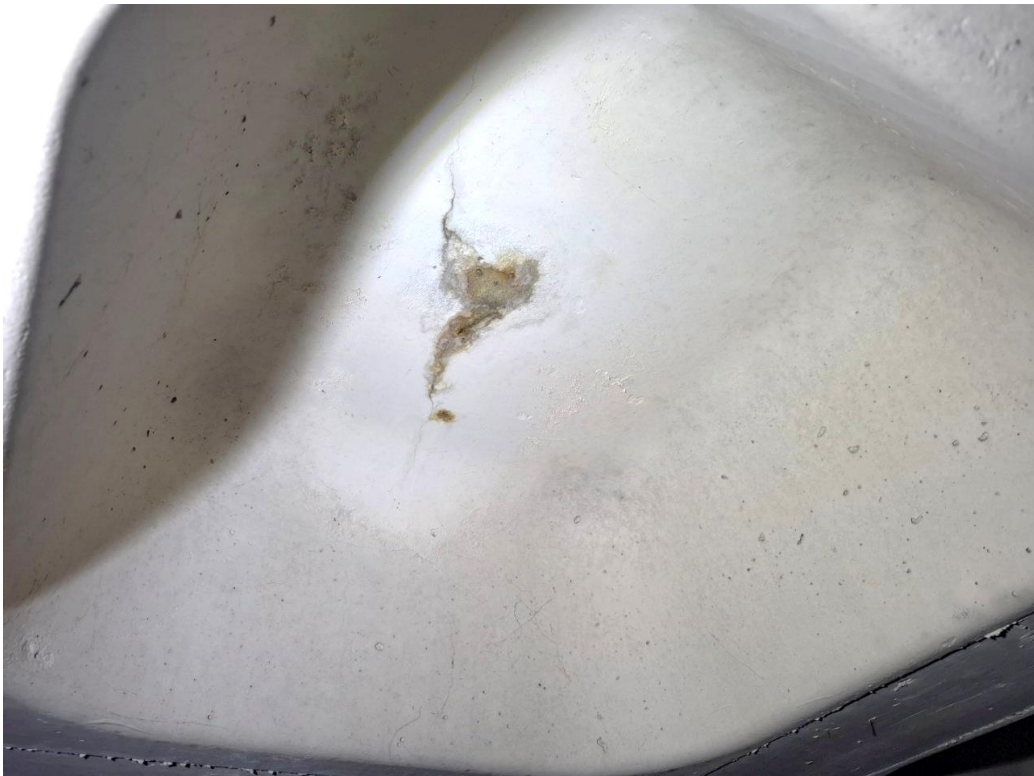
Photograph 2 – local staining from corroding reinforcement
