## **Structural Inspection Report and Appraisal**

**Project:** Linen Street Carpark  
Warwick  
CV34 4DT

**Client:** Warwick District Council

**Reference:** M45320-JNP-XX-XX-RP-S-1001 P01

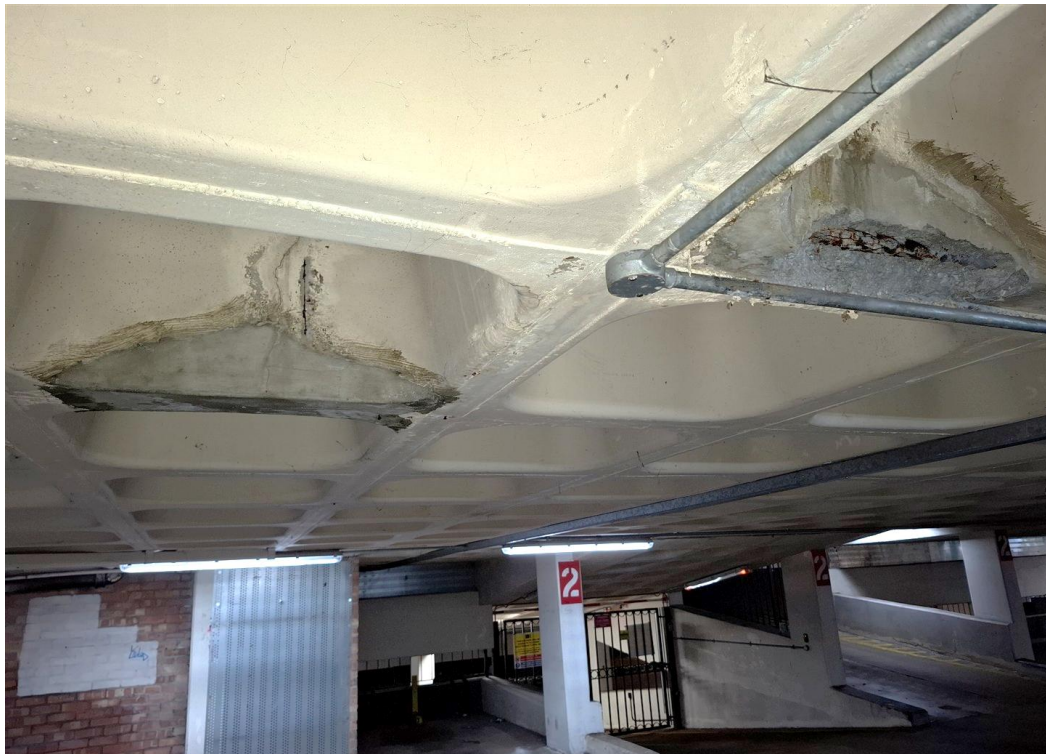
**Photograph 01: Previous repairs**

- 5.1.1 Restrict the areas of parking to where there are no evident defects present. This includes all previously repaired areas, and areas where there is increased risk of local concrete failure due to staining, deformation or other visual indicators.
- 5.1.2 Defects exist in the trafficked areas, between the car parking spaces. These areas will remain a higher risk, however, the likelihood of a pedestrian or vehicle being present should concrete fall from the soffit of the slab is considered low.
- 5.1.3 It may be possible to reduce the risk further by creating a physical method of catching/controlling any falling debris. This would be considered a short-term fix and will need to be developed by WDC alongside JNP Group before consideration.

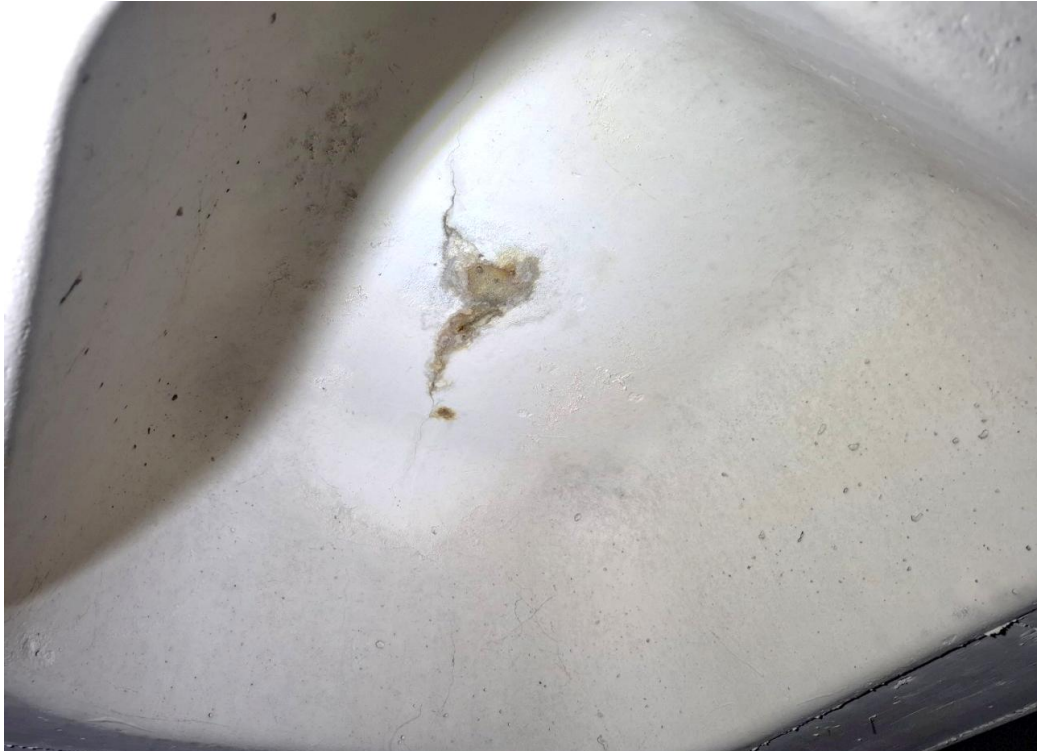
**Photograph 02: local staining from corroding reinforcement**
