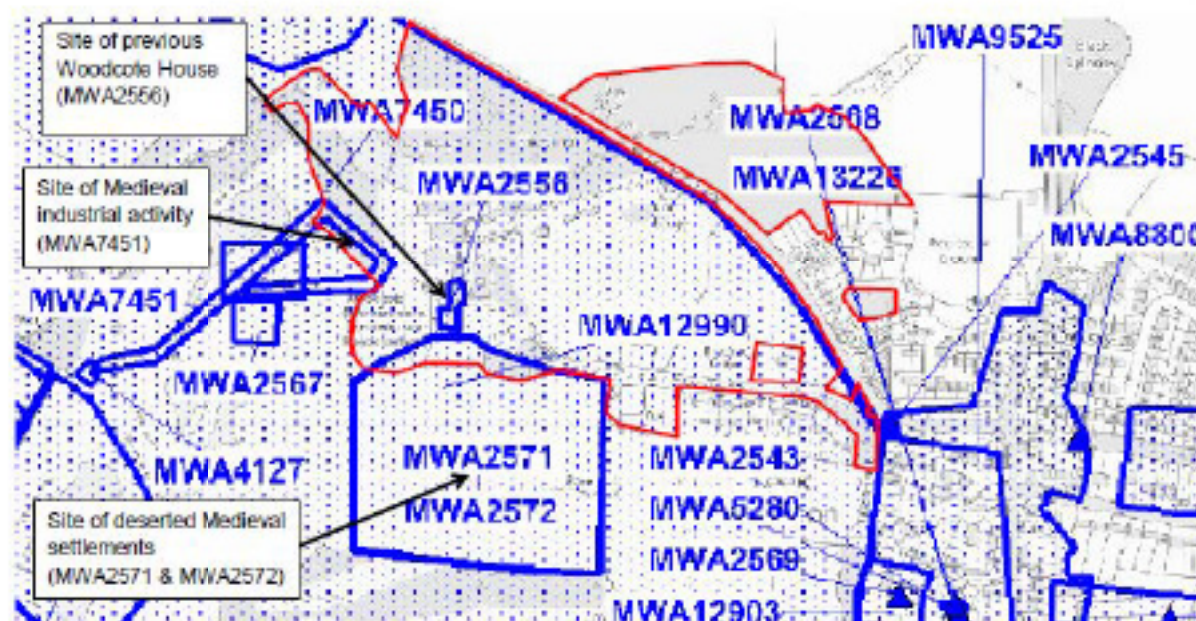
Areas of Recorded Archaeology

78. Excavation underneath the golf course at Fox Covert (HER Ref MWA7450) revealed Medieval industrial activity in the form of pits, gullies and burnt material deposits. This area strays into the north western edge of the site, and represents an area of potential archaeological sensitivity based on the results of previous excavations.

79. Documentary evidence suggests that a site lies just south of the Police Headquarters at Leek Wootton may once have been the site of the Medieval settlements of Lower Woodcote and Upper Woodcote (HER Ref MWA2571 & MWA2572). This area strays into the lawn and garden area south of the House and represents an area of potential

80. The extent of the area has not been tested, and the majority has been thoroughly landscaped as part of the construction of the golf course. Development within this area may require archaeological evaluation (trial excavations) prior to the determination of planning applications.

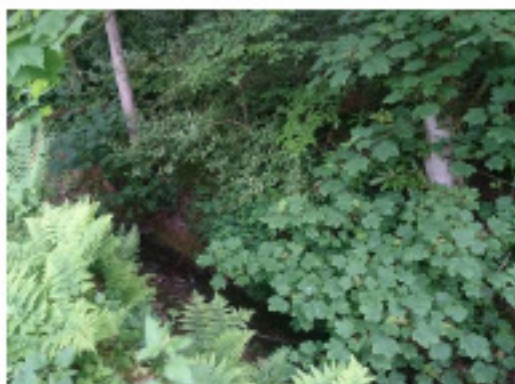
15. The Cattle Brook enters the north western boundary of the site where it flows into a lake within the north-western portion of the site. The lake has a small sluice located on the south east bank of the lake. When the lake reaches a certain level, water flows over the sluice and into a smaller lake, located beneath the top lake. To the south of the lake there is an overflow weir where water discharges back into the Cattle Brook.
16. After flowing through the two lakes, the Cattle Brook continues through a narrow valley which is approximately 2m below the surrounding site levels. It is understood that this valley was excavated to ensure the Brook remains free flowing and to accommodate additional surface water from the buildings located to the south of the Brook. The Brook eventually discharges into the River Avon, approximately 2km to the east of the site.

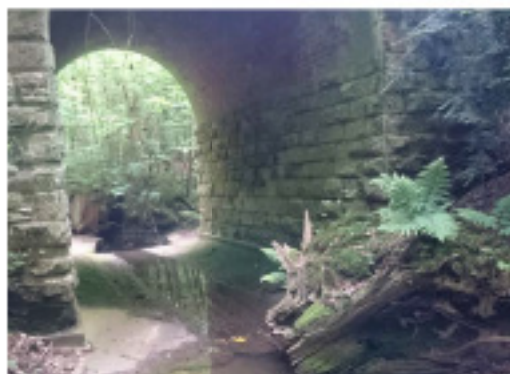
Cattle Brook flowing under Woodcote Lane Bridge

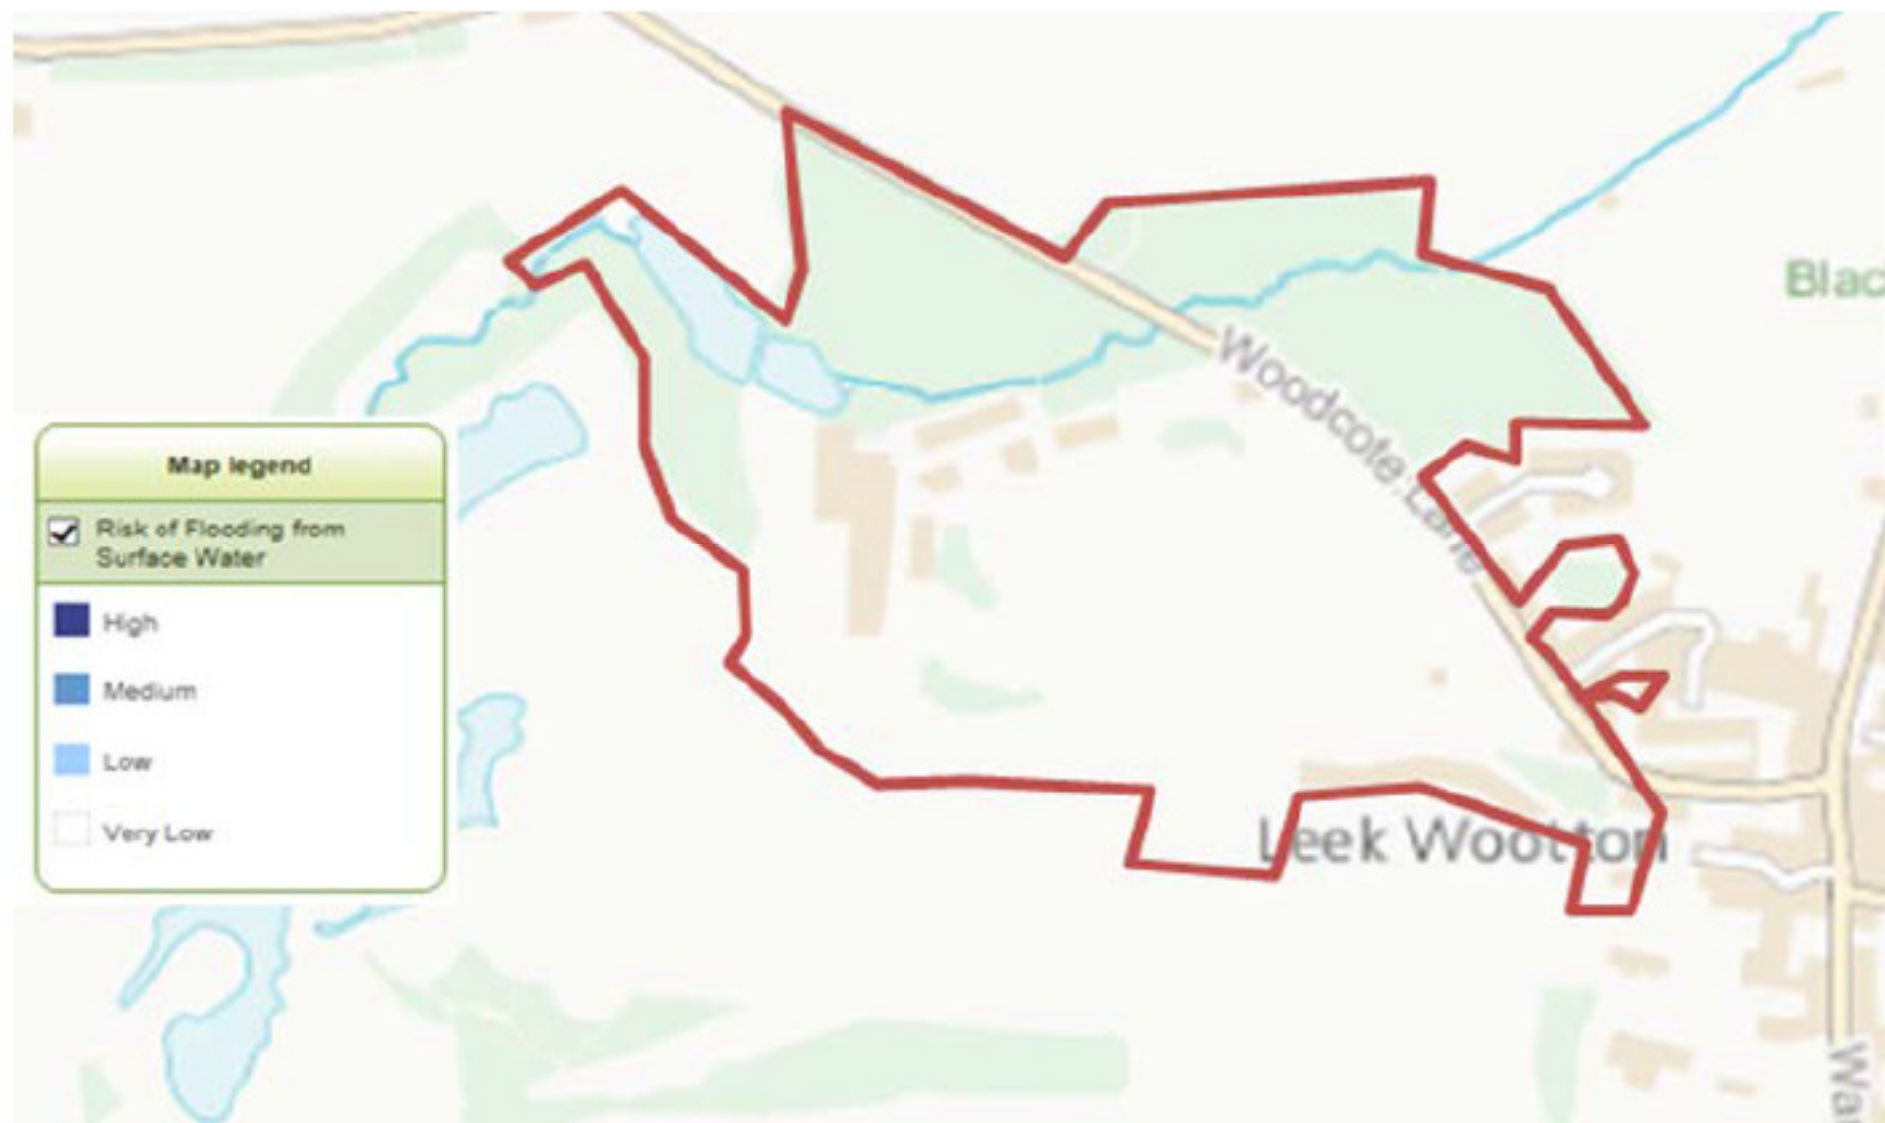
Environment Agency Surface Water Map

19. Surface water flooding (otherwise known as pluvial) is the term used to describe flooding which occurs when intense, often short duration rainfall is unable to be conveyed either into the ground or a drainage network, and as a consequence flows over ground on the surface causing flooding.
20. According to the Environment Agency Surface Water Map, the majority of the site is at 'very low' risk of flooding from surface water.

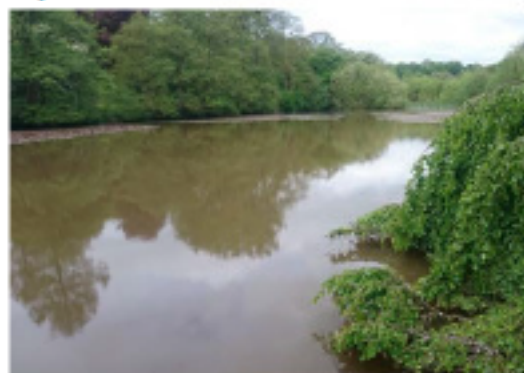
Top Lake

32. For the purposes of this report the lake located within the extreme north-western part of the site has been titled 'Top Lake'.
33. This lake is approximately 5,000m³ in volume (based on a 1m average depth). The Cattle Brook flows into the north-western part of the lake. The lake is dammed at the south-eastern end and there is an overflow sluice

located along the northern section of the wall.

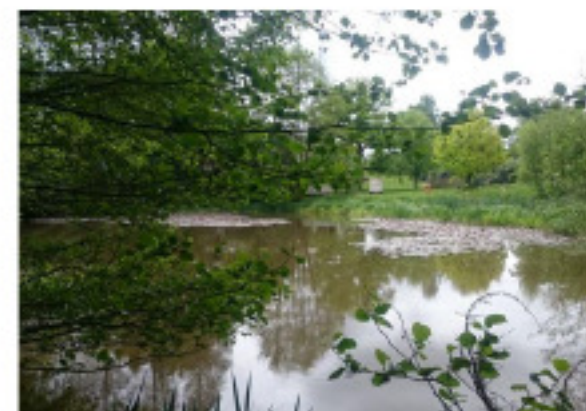
Bottom Lake

34. Directly below the Top Lake is a second, smaller lake, titled 'Bottom Lake' for the purposes of this report. This lake is approximately 1,600m³ in volume (based on a 1m average depth). The lake is fed by the Top Lake and water discharges from this smaller Lake over a weir, back into the Cattle Brook.

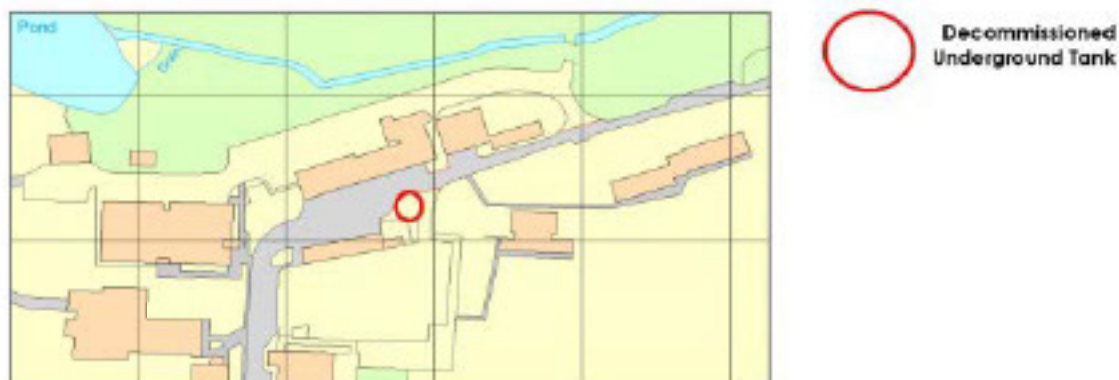
Figure A5.1: Decommissioned Tank

65. These are shown on Figures A5.1 and A5.2. In both instances ground investigation and remediation may be required ahead of development.

18. Our site inspection identified a number of underground and above ground fuel/oil storage tanks located on the site.
19. No visual evidence of ground contamination was noted around these locations.
20. In the event of redevelopment, consideration will need to be made for further investigation/remediation in these areas.
