Archaeological Evaluation of  
the former Leper Hospital, Saltisford,  
Warwick

Report 0445

December 2004

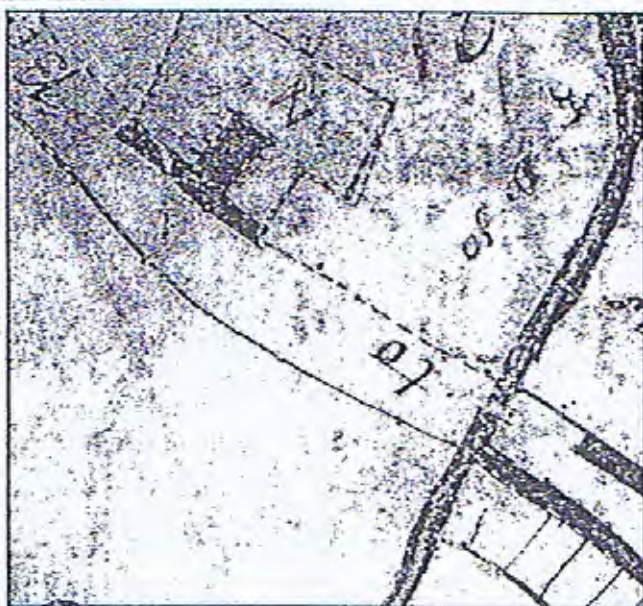
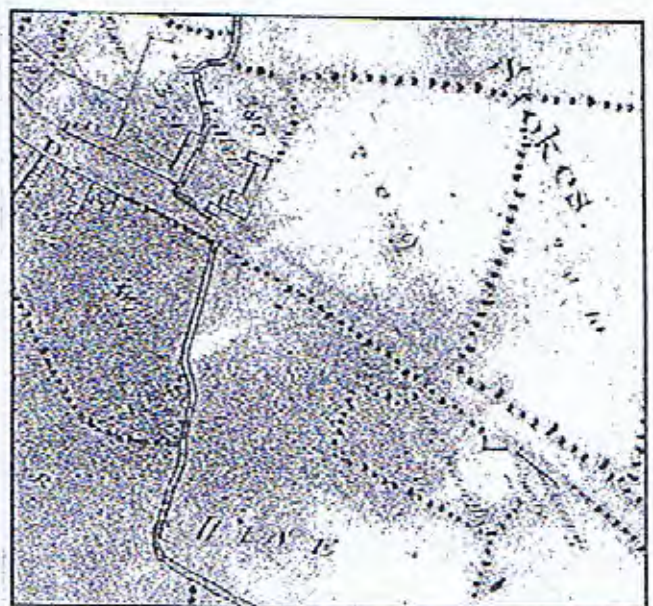
Fig. 3: Details from a) Fish and Bridgeman map of 1711, b) Baker map of 1788

4.5 A plan of 1711 also shows a range of buildings along the street frontage to the south-east of the Chapel (Fish and Bridgeman 1711, Fig. 3). This plan is fairly schematic showing a chapel at right angles to the road frontage with buildings running along the frontage to either side, but there is no representation of the Master's House. It is probably accurate in showing the road frontage occupied by buildings. It also shows the plot within which the structures lay as protruding to the south-east to the rear. This may be the result of pre-existing structures in separate ownership along the road frontage in the medieval period that had since been abandoned. The rear boundary is shown as a straight line running roughly north-west to south-east, parallel to the road and not far from to the north-east wall of the Master's House (WCRO PH210/182/21, Fig. 7). The current development area extends beyond this boundary to the north-east into an area that was probably occupied by fields and is shown as being in agricultural use on more detailed later maps. It is likely that this area always lay outside the precinct of the Leper Hospital and was in use for agriculture from the medieval period onwards.

4.6 The area remained isolated from the town throughout the 18th century and into the 19th century. Contemporary plans (Baker 1788, WCRO Z122(u), Fig. 3; James 1806 WCRO Z276/2(u)) show the area in better detail. The Almshouses along the street frontage to the west of the Chapel formed part of Thomas Puckering's Charity (VCH 1969, 550) and lay within a small enclosure, separate from the Chapel and the rest of the precinct. The Chapel itself is shown at an angle to the street frontage, though once again there is no representation of the Master's House. In 1806 the property within which the Chapel lay was let by a Mrs Allworthy and owned by

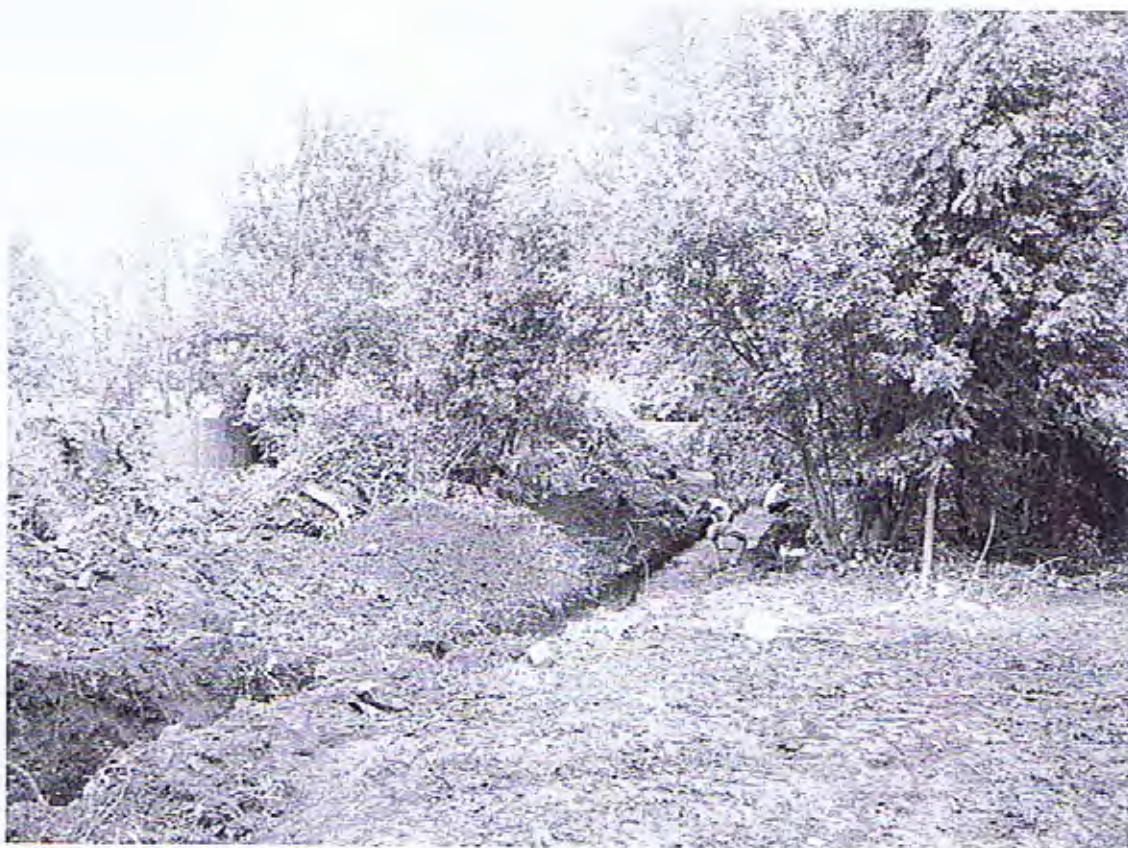
Fig. 10: Trench 1 looking west

5.2 Trench 1 measured 30m long by 1.6m wide and was aligned roughly north-west to south-east in the north-western corner of the current proposal area outside the Scheduled Area (Fig. 8). Geological natural was in the form of outcropping sandstone (103), overlain by layers of reddish brown clay (107, 109) and alluvial deposits (102). The natural was encountered at between 55.10m AOD and 54.94m AOD. The depth of the trench varied between 0.18m at the north-west end of the trench and 1.10m at the south-east end; the difference being the result of a large deposit of modern material (see below 104).

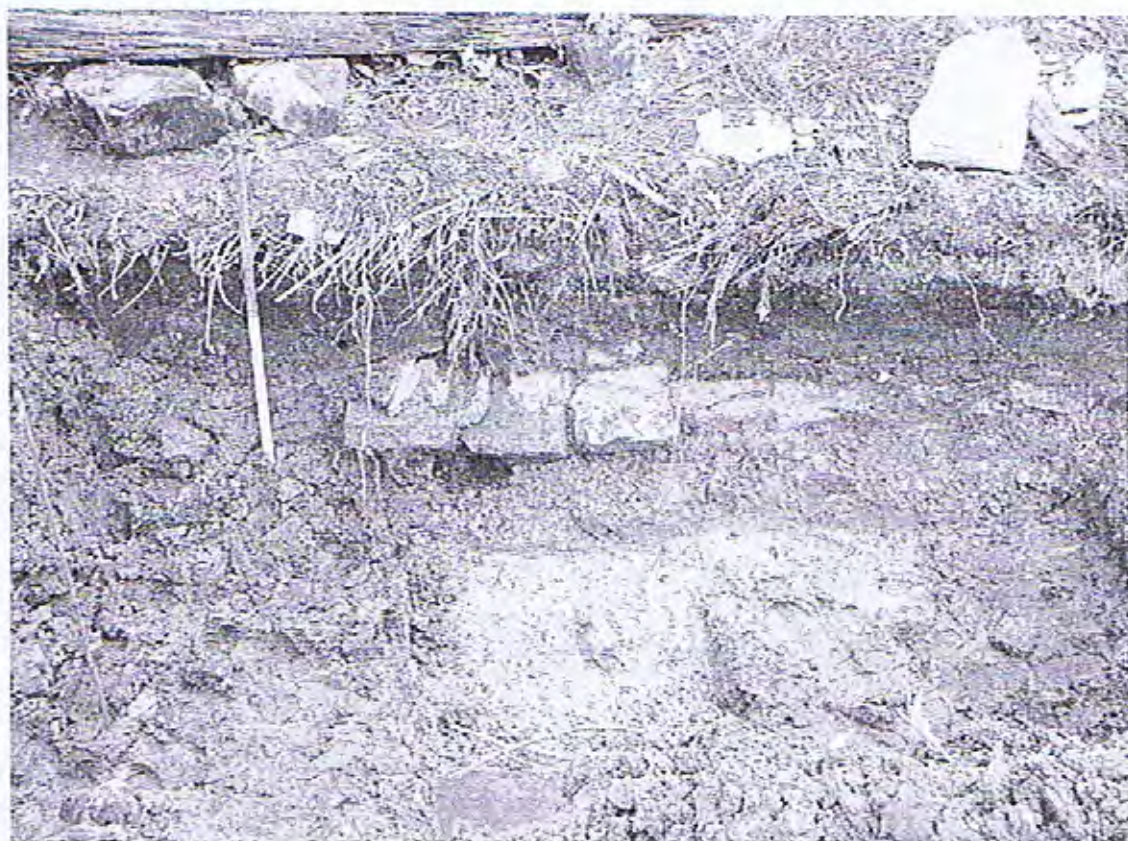
Fig. 11: Trench 3, wall 305 and ditch 304

5.10 Immediately to the south-west of the ditch, running parallel and probably cut by it, was a sandstone wall foundation (305, 309, Fig. 11). This may represent another boundary feature or the remains of a building just inside the Hospital boundary and may have been of medieval date. The precise relationship of wall 305/309 with ditch 304 was however uncertain, and it may alternatively have represented masonry fallen into the ditch.

5.11 Due to excessive ground water within the trench it was not possible to obtain a clear profile of ditch 304. It is likely that the full extent of the ditch extended beyond the limit of the trench. The bottom of the ditch was apparently revealed, but no detailed investigation was possible. Ditch 304 was backfilled with various alluvial deposits (301, 302, 303) from which material of 19th century date was recovered along with residual medieval and later pottery.

5.12 Ditch fill 302 was overlaid by a spread of decomposed masonry (310) from Wall 305, and both 310 and 305 were overlaid by a layer of brownish sandy loam with occasional mortar flecks (308). The backfilled ditch and the remainder of Trench 3 were overlain by modern levelling and topsoil deposits (300, 306, 307).

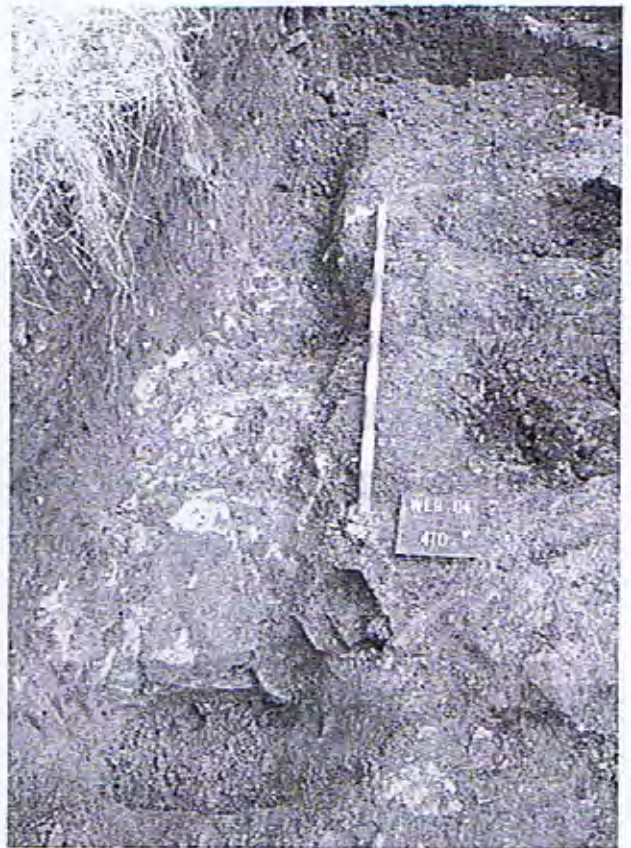
Fig.16: Trench 4b, wall 410

5.16 At the south-east end of Trench 4b layer 432/473/494 was cut by the foundation of a large mortared sandstone wall (410, Fig. 14) running north-east to south-west, at right angles to the earlier posthole alignment (431/429/424/459). A single sherd of 13th-century pottery was recovered from the foundation, which may have belonged to the early church or to the early period of the Leper Hospital. A less substantial sandstone wall foundation (405), with no apparent bonding, ran roughly north-south from the south-eastern edge wall 410 and may have been a boundary feature. To the north-west was a north-south aligned gully (412), perhaps a drain, and a probable pit (435). If the building formed by wall 410 extended to the north-west, as seems probable, then gully 412 and pit 435 are unlikely to have been contemporary with it and were probably earlier features.

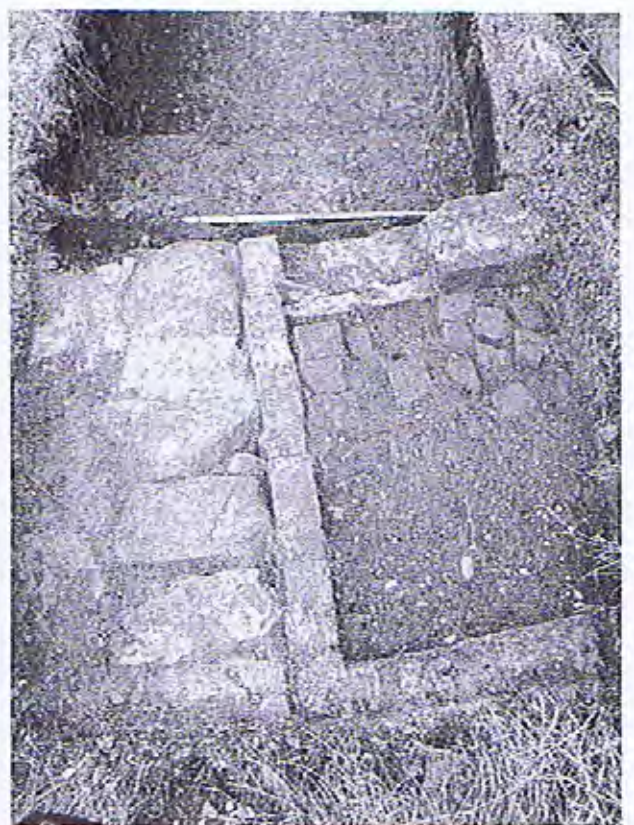
Fig. 18: Trench 4a, walls 415 and 417

5.19 At the south-west end of Trench 4 a sandstone wall (417, Fig. 16) was aligned north-east to south-west at right angles to the road frontage. This area was not fully excavated down to the medieval deposits, and the wall lay at a high level, but it is possible that it dates from the 17th century or earlier. It may represent the buildings of Puckering's Almshouses shown on maps from the 18th century, the street frontage buildings recorded in the 17th century. Photographs taken before the demolition of the latest street frontage buildings show them to have been built of brick and of probable 18th/early 19th century date. The stone foundations are likely to have been laid down for buildings that preceded these.
