VISITOR ACCESSIBILITY

ACCESS AUDIT

The Access Audit assesses the quality of access within and to the Fields in terms of its visibility, legibility and accessibility for both able bodied and less abled bodied users and is supported by the Access and Circulation Plan. The audit has looked at the following:

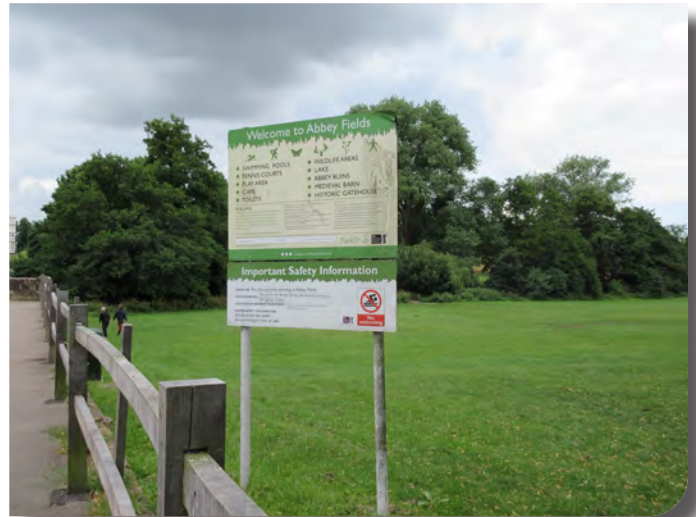
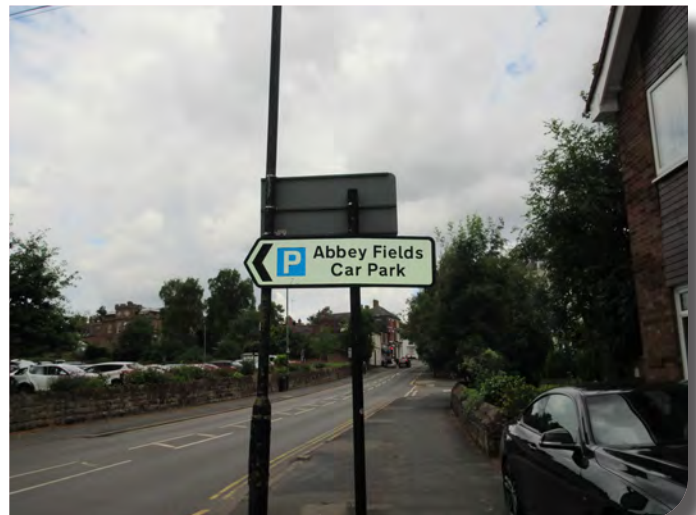
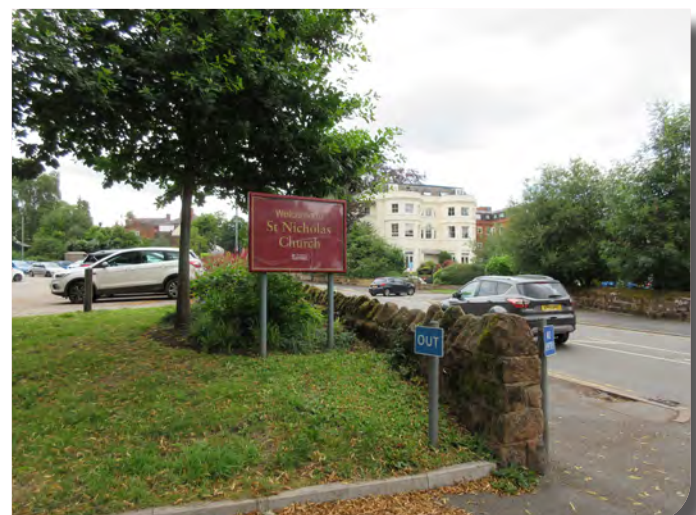
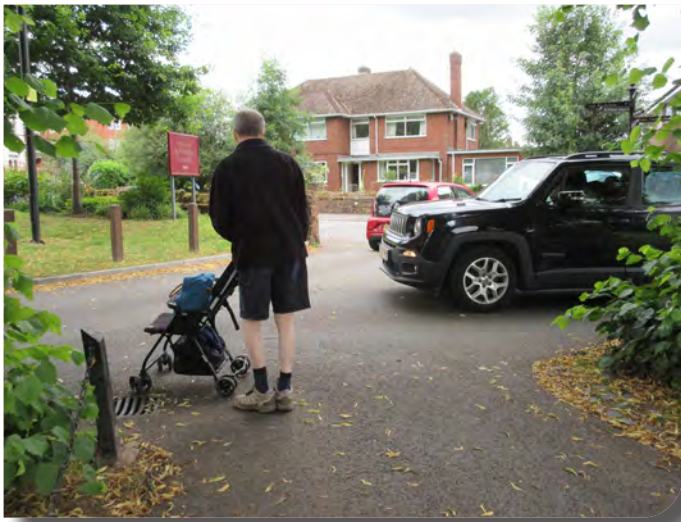
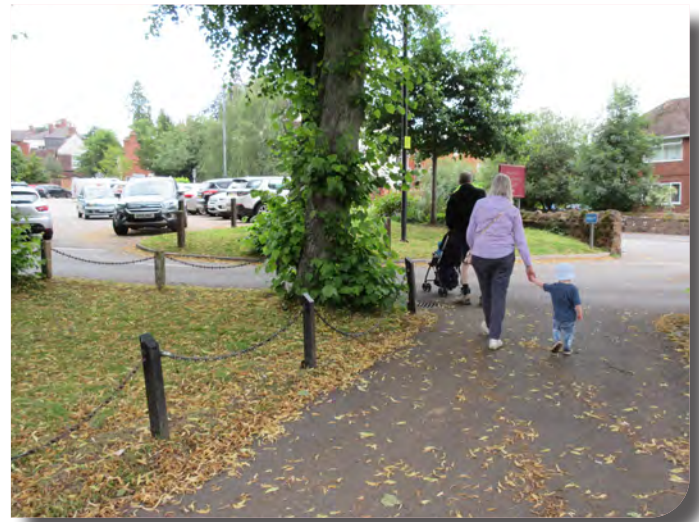
Car park

The car park is a primary entrance for vehicle users to Abbey Fields, St Nicholas Church and the leisure facility. As a result, it is also a primary entrance for pedestrians with two main points of pedestrian access from the car park. There is one welcome sign near to the car park entrance to advertise Abbey Fields/Abbey Ruins but it has too much information and is easily missed. It also faces away from the town centre, missing all vehicle users exiting the town. The legible road signage directs to Abbey Fields Car Park with a large sign 'Welcome to St Nicholas Church'.

The vehicle entrance to the car park shares the driveway despite having a separate 'in' and 'out' from Bridge Street. This results in vehicles coming into conflict with each other at the entrance.

The main pedestrian access to the Fields and leisure facility to the east of the car park also shares the narrow vehicle access, which often causes conflict between pedestrians and cars. Pedestrians with prams, young children and wheelchairs are most at risk.

The main pedestrian access to the Fields and church to the west of the car park is very narrow and creates a pinch point between a mature tree and post with chains. Wheelchairs and wider prams struggle to negotiate this path.

- **West path – widen the path and create a good sized, well designed primary entrance.**
- **East path – suggest providing a safe pedestrian route that connects from the rear of vehicles parked along the Church Walk.**
- **Consider replacement of the chains and posts with a series of bollards as detailed in the Design Guide to allow for improved permeability into Abbey Fields, whilst continuing to prevent unauthorized vehicle entry.**
- **Vehicle access signage needs to be considered to encourage visitors into Abbey Fields, to complement Kenilworth Castle.**
- **Apply for brown signage for Abbey Fields.**

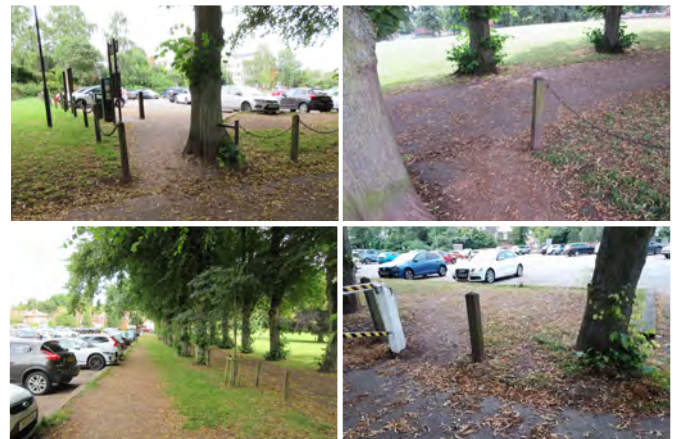
Chains and posts run the length of Church Walk parallel to the car park and are an historical feature designed to prevent unauthorized vehicles entering the Fields. However, without clear safe

primary entry points to the Fields, this barrier has restricted the permeability (flow of people) of the Fields and forces older and younger pedestrians to negotiate vehicles entering the car park. It has not prevented able bodied pedestrian movement as pedestrians frequently climb over the chains. Accessibility has therefore become more difficult and dangerous for many users as a result.

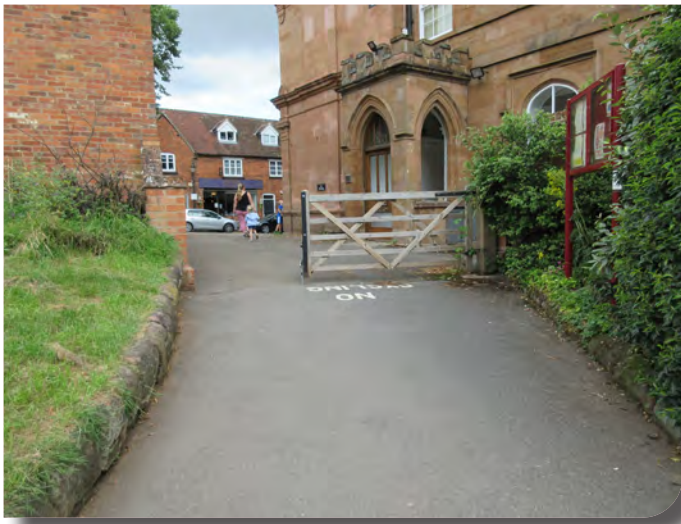
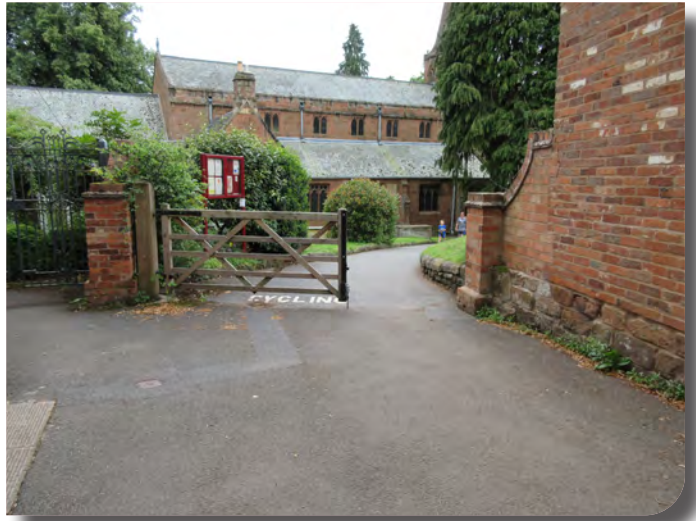
High Street – north east entrance

A primary access to St Nicholas Church, the Abbey Ruins and Abbey Fields beyond. This has a sub gate vehicle access timber field gate with gap for pedestrians.

- **To encourage greater use of this entrance, finger posts need to be located where they are clearly visible.**
- **Signage at the entrance to the church should be identifiable and if possible combined with Abbey Fields signage.**

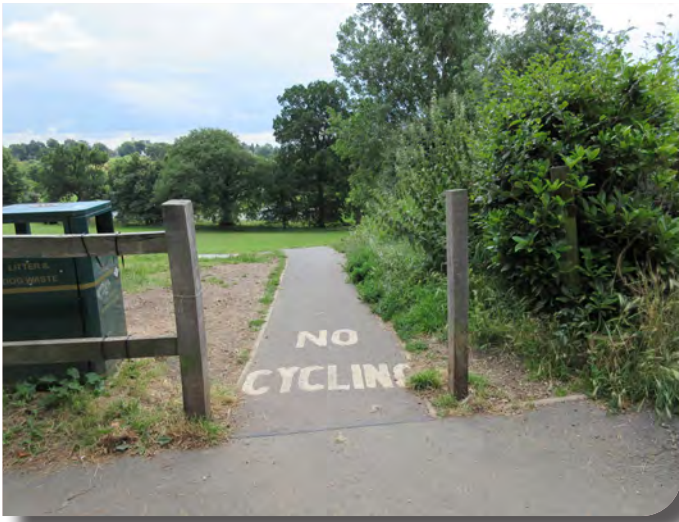
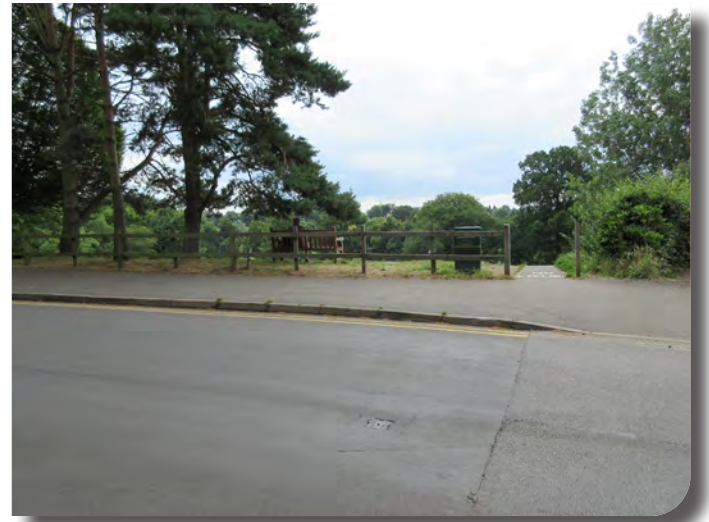
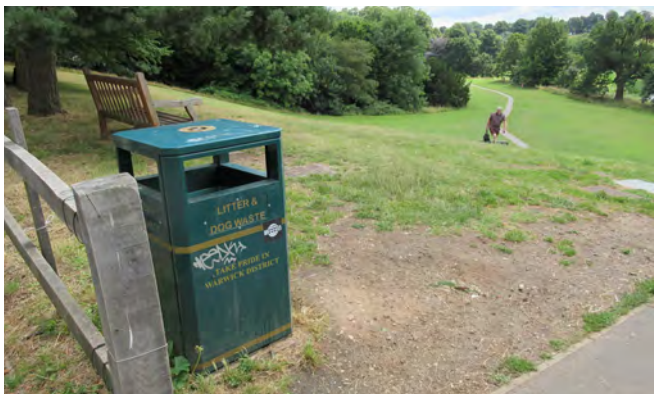
High Street – north west entrance

This is a well-used entrance to Abbey Fields for pedestrians north of the Fields. It is a pleasant entrance but considering the volume of users at this entrance it is narrow, lacks principality and entrance signage.

The Centenary Way long distance route appears to enter through the Fields at this point (although there is conflicting mapping data to confirm), but there are no way markers. The entrance is also close to a resident's driveway with potential conflict with vehicles and pedestrians.

- **Move the entrance further east to avoid the driveway.**
- **Widen the entrance to create more principality and legibility. Erosion around infrastructure at the entrance suggests a well-used bin and seat in this location which would benefit being set in hard standing with path access.**
- **Provide entrance signage and way markers to improve the experience of pedestrians accessing the Fields.**

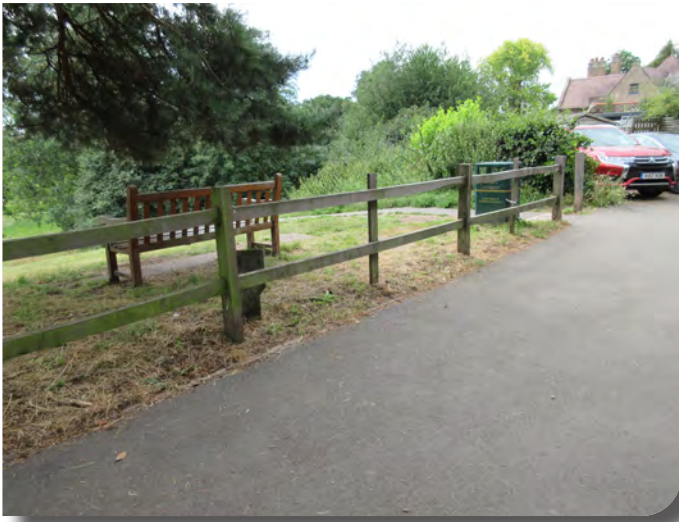
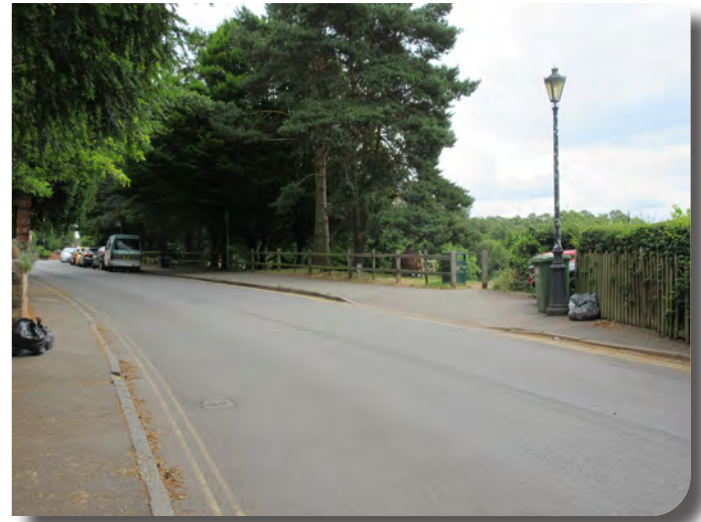
Castle Road West entrances

There are two primary entrance points at this location that receive a large number of visitors. These entrances are in close proximity to Kenilworth Castle. The entrances lead off a raised footbridge adjacent to the Castle Road ford that sits on a lower elevation over Finham Brook. The footpath bridge is fenced to the road and the brook.

This has caused much erosion of grass verges particularly to the Fields side of the entrance. The concern with regards to access is the fear of entry due to poor intervisibility.

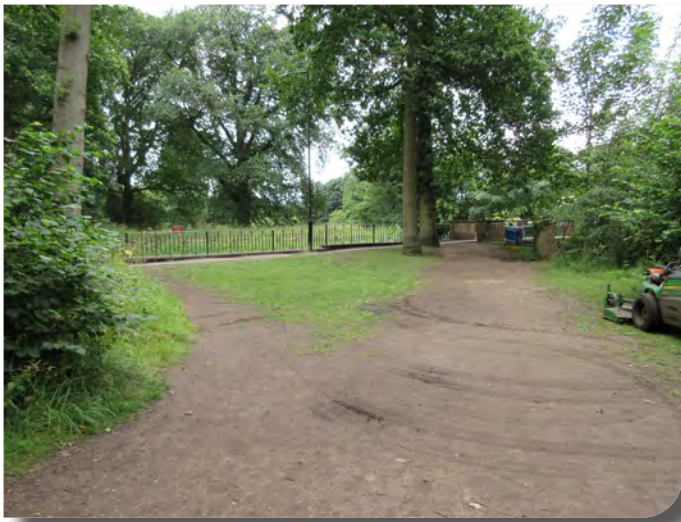
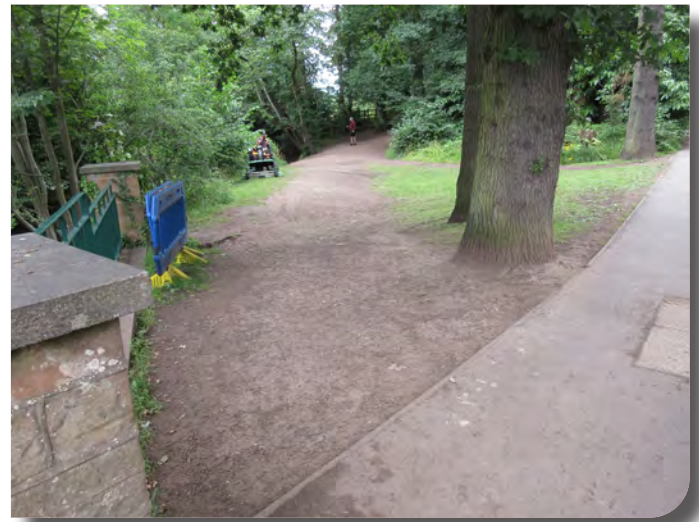
Entrance south of Finham Brook

The entrance south of the brook is a more informal entrance, although very well used with 2 worn paths to the north and south of a triangular grass verge that has been left uneroded by default. The ground is bare earth due to substantial footfall erosion that has resulted in a trip hazard to the edging kerb of the roadside footpath.

The erosion broadens and continues well past the entrance paths, to the water's edge and beyond the timber entrance gate.

The erosion into the brook is due to dog and pedestrian encroachment. However this has extended beyond the beach area. Erosion near to the bridge parapets may eventually cause issues of undermining the structures.

- **The paths from the roadside footpath would benefit formalization. However, there are mature trees adjacent to these paths restricting path creation. It may be that a new formalized hard surfaced path is created within the central triangular grass verge, with a wide chamfered entrance to north and south, with fencing near the road footway to direct pedestrians and remove the two desire lines. This may also reduce dog generated erosion near to the bridge parapet.**
- **Access to Finham Brook further away from the parapet could be encouraged for dogs and people as it is a low and safe access and egress from the water's edge. Information in relation to encouraging access here and avoiding the bridge parapets would be of benefit to many.**

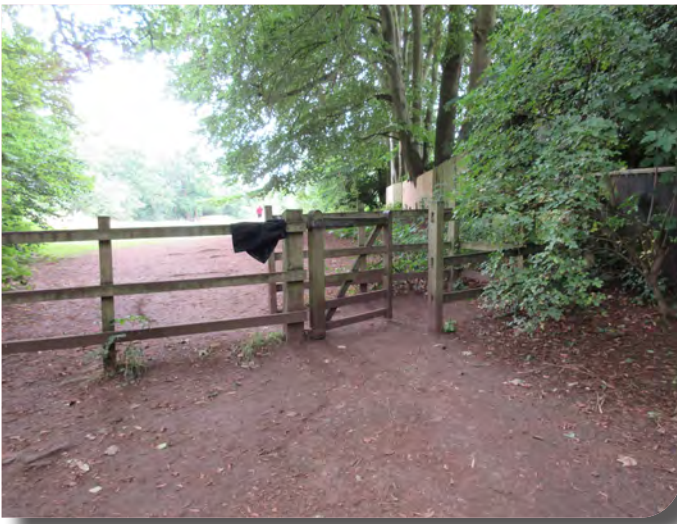
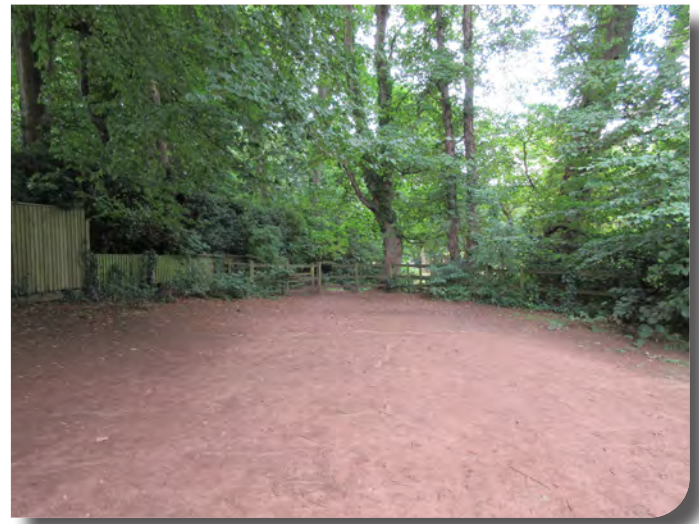
It appears post and rail fencing have been installed further east from the beach to limit the spread of bank erosion and to direct pedestrian movement to the kissing gate. Informal timber and compacted hardcore steps are located south of a mature tree but they are slowly being covered by brambles

and nettles encouraging people to find alternative sloped routes around the tree exposing a vast array of roots.

The kissing gate, introduced to prevent horse riding within the Fields, acts as a pinch point to the volume of footfall in this area. Erosion around and beyond it is wide and extensive, likely caused by substantial wet areas which are then avoided causing a vicious circle.

- Erosion around the tree adjacent to the steps could be reduced with removal of brambles and control of vegetation along the boundary fence and the steps to encourage use of the steps. Directional fencing could be used to block off the access to the north of the tree and encourage pedestrians further south of the tree into an area that has already received compacted hard core over time.
- The kissing gate could be replaced with a wider opening in the fenceline with timber bollards. A wide path would need to be constructed to reduce erosion. Root Protection cellular footpaths could be used here if tree roots are a concern, although tarmac paths may be preferable. Improved drainage within this area would assist with issues of wet ground.

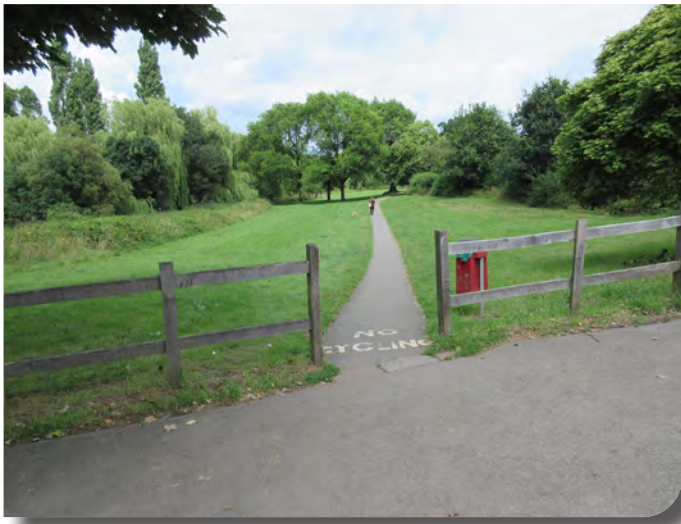
[Borrowell Lane/Forrest Road south entrance](#)

This is a well-used pedestrian entrance to Abbey Fields particularly from the National off-road cycleway (Sustrans 52) that ends at Borrowell Lane, connecting the areas of Borrowell and St Johns to Abbey Fields.

- **Good entrance signage directing pedestrians into the Fields as well as widening the access and introducing bollards as per the Design Guide would improve its accessibility, legibility and principality.**

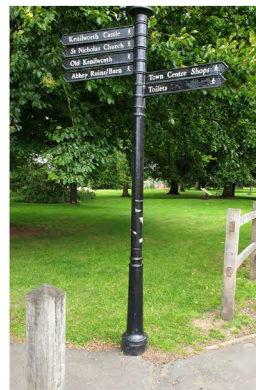
There is one black finger post within the town centre that directs to Abbey Ruins, St Nicholas Church and Toilets, but does not include the Fields or leisure facility. The sign is also tucked within trees, adjacent to outdoor café seating and is easily missed.

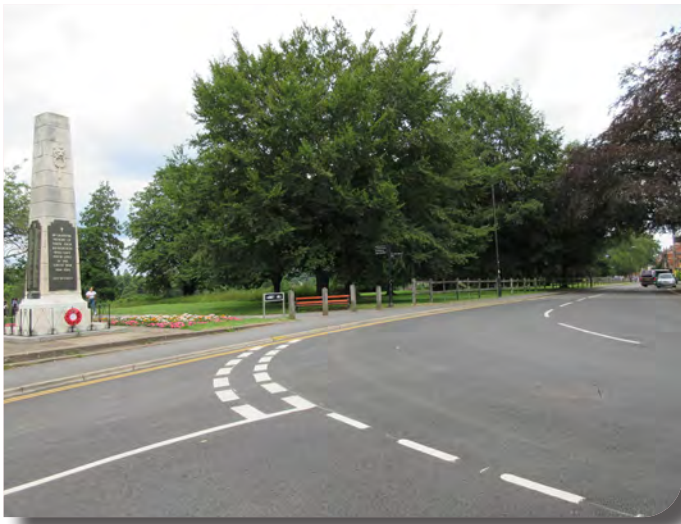
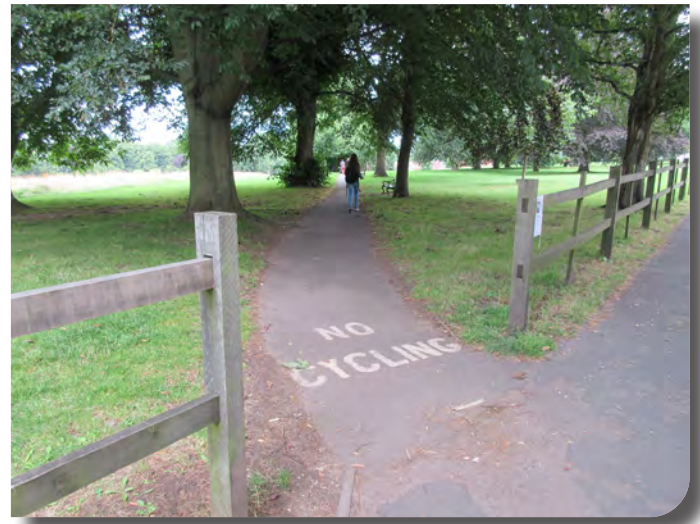
War memorial entrance

The war memorial entrance is an open and wide entrance with timber bollards preventing vehicle access. Access is also available through the war memorial although this is not wheelchair friendly as it is stepped to the front and rear.

An old finger post is located adjacent to the entrance that directs to important features within the Fields except for the play area, lake and leisure facility.

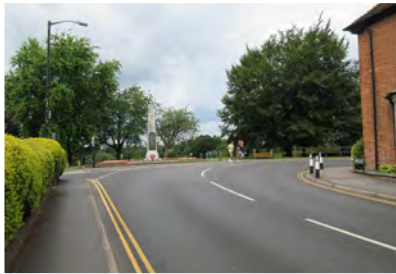
A road name sign is located in principal view adjacent to the war memorial. The orange bench and road name sign also become detracting focal points.

Issue here is the lack of formal crossing at a busy junction/bend on a major road out of the town.

- **The Holmes Avenue entrances at Abbey Hill and Bridge Street would benefit welcome signage and some historic context.**
- **Install a crossing point at Abbey Hill between Holmes Avenue and the War memorial entrance to encourage safe crossing. This will provide pedestrians safe passage into and out of the Fields across this busy road.**

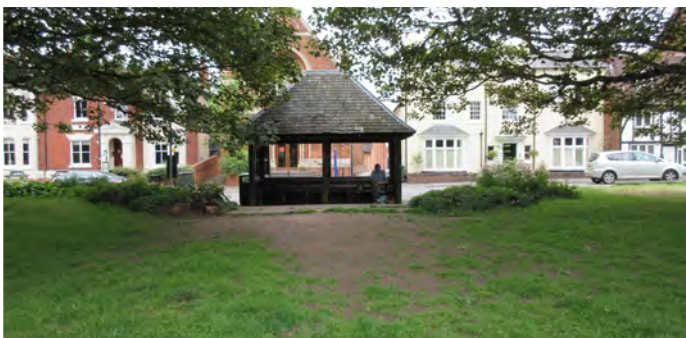
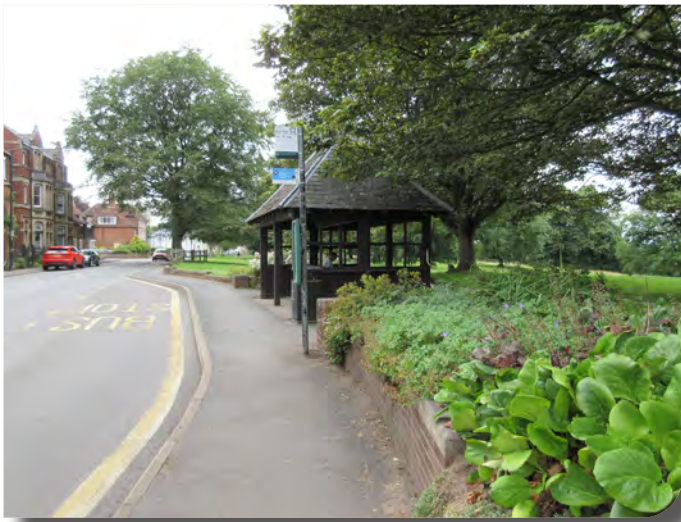
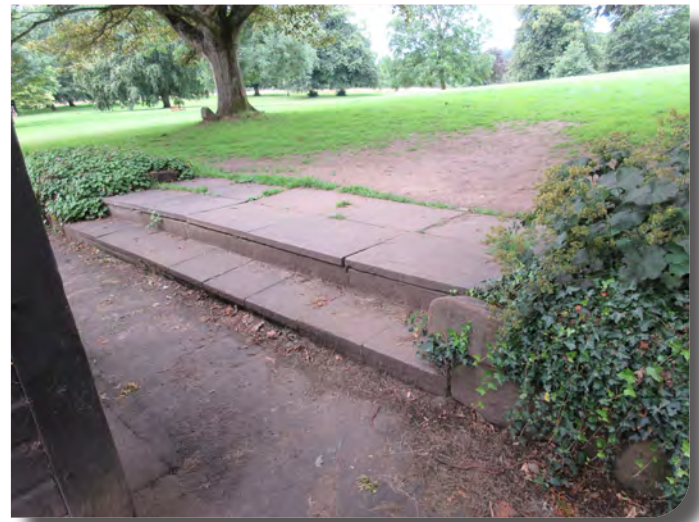
Proposed Primary access at Abbey Hill shelter

An informal broad, stepped entrance is located to the rear of a large timber double sided shelter and offline bus stop along Abbey Hill near to the junction with Upper Rosemary Hill and Priory Road.

This entrance appears to have high footfall although it is partially hidden from the road behind the shelter.

The access is framed by pretty raised herbaceous borders that create a pleasant frontage. Narrow paths to the rear of the shelter and broad steps leading into the Fields restrict access to able bodied pedestrians. Footfall erosion is an issue leading from the steps as there are no formal paths from the steps into the Fields.

The steps are in serviceable condition but the tarmac paths are in need of improvement. The shelter is also in need of maintenance.

- **This entrance could receive substantial improvements and would benefit erosion control around the base of the paths to reduce trip hazards.**
- **The entrance would benefit wider paths and upgrade to steps to the rear of the shelter to create a more inviting space.**
- **The shelter requires repair and maintenance to create a high-quality entrance experience.**
- **Entrance signage to the Fields would invite visitors into Abbey Fields from the bus stop.**
- **Access across Abbey Hill also needs consideration with a crossing point to ease permeability with residents, schools and businesses to the east and south of Abbey Fields.**

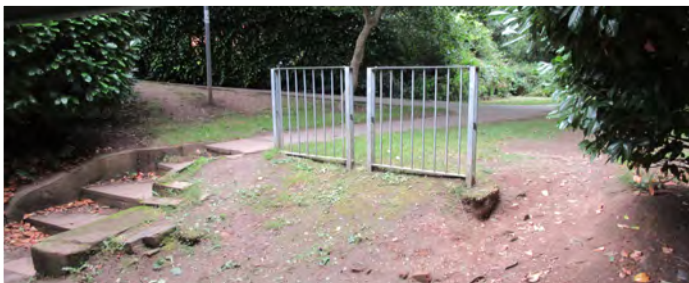
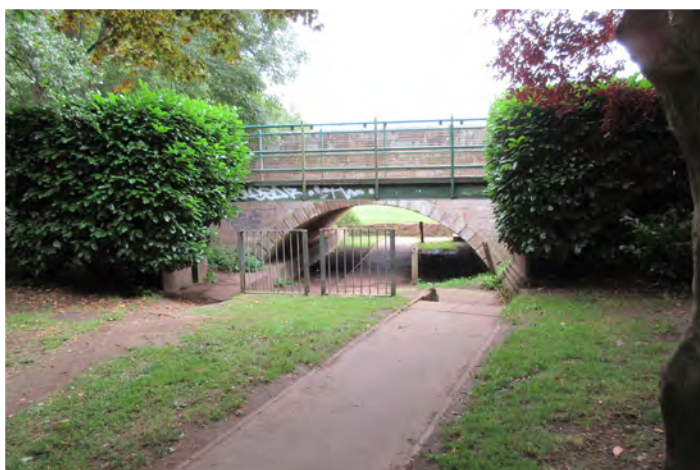
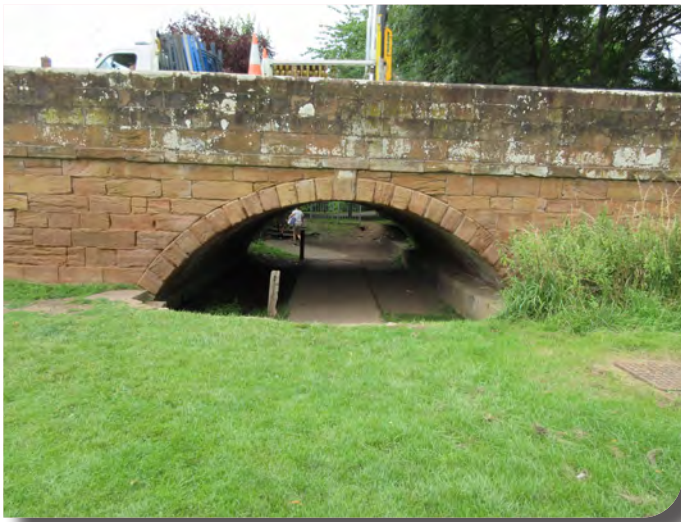
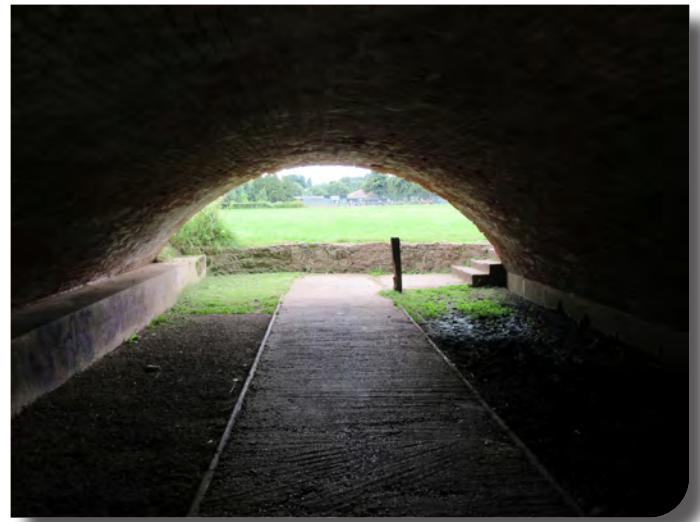
Footpath under Bridge Street

This is a formal pedestrian link leading under Castle Road bridge. It is a pedestrian only path that connects to the off road National Cycle Route (Sustrans 52) that links Abbey Fields with Kenilworth Common and beyond.

Steps and ramps lead down under the bridge to allow for head room. This is a well used route by pedestrians to avoid crossing the road and negotiating the car park entrance.

There is footfall erosion around the entrance points and muddy areas under the bridge as it is a basin and collects water. Drainage is provided to ensure this flows away when possible.

Timber cycle finger posts do not advertise Abbey Fields but suggest cycle connections to University of Warwick and the Town Centre (via vehicle routes).

- **Welcome signage to the Fields would encourage pedestrians from along the footpath/cycleway to explore the Fields fully.**

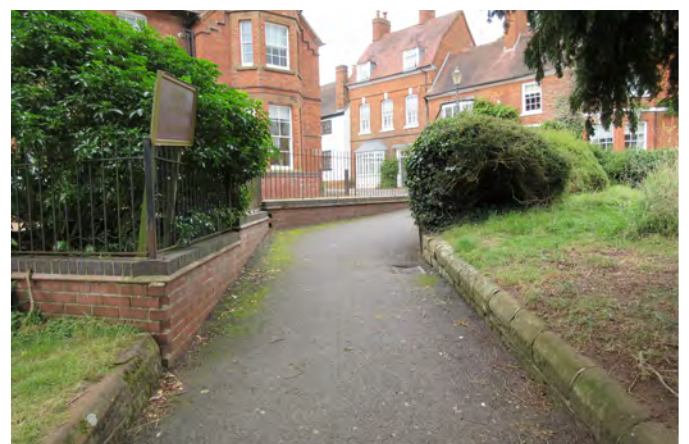
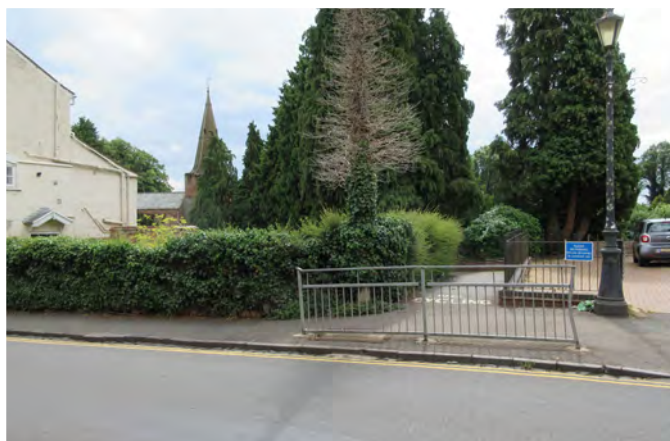
Church entrance

A secondary, narrow, formal tarmacked entrance leads to St Nicholas Church from High Street. Iron railings line the western edge with a wide hedge to the east, creating a narrow alley way that feels intimidating and uninviting. There is no signage to indicate its connection to the Fields. An old

This is an historic route into the church with stone edging and mature trees lining the main path to the church. A community church garden lies further east of the entrance beyond the wide hedge. However, access and visibility are impeded by the hedge.

The Centenary Way long distance route appears to enter/exit through the churchyard at this point (although there is conflicting mapping data to confirm). However, there are no way markers to show its use of this path.

- **Remove the wide hedge alongside the path to create an open view of the church and churchyard and improve access. Perennial borders could be introduced along the boundary to allow views in, but limit access to the churchyard if required.**
- **Provide signage to the church and Fields beyond, with way markers defining the route of Centenary Way.**

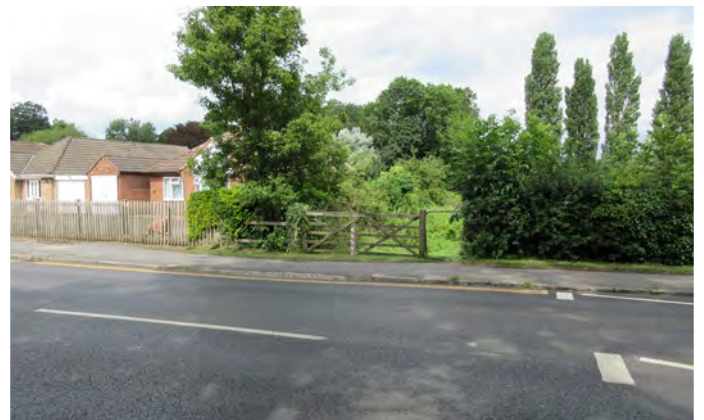
This is a combined vehicle and pedestrian access. The vehicle access is via a rotting timber field gate with rotten posts with a lockable bollard. The pedestrian access is adjacent and via an old metal hooped chicane.

This is a mown access with wild margins. It appears well used as there is a formal zebra crossing over the main road linking to access to the south and south west. It is a very wet access.

- **Replace the field gate with similar, in line with Design Guide. Replace metal hooped chicane with timber.**

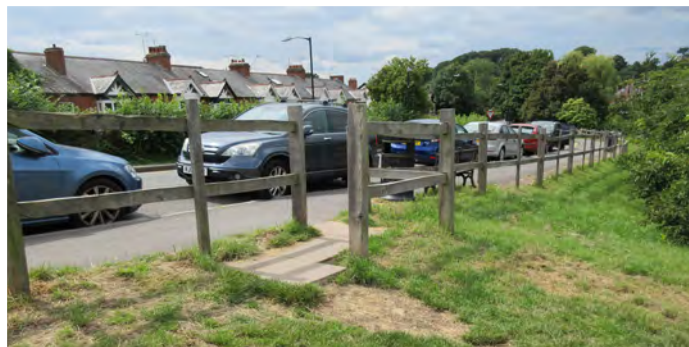
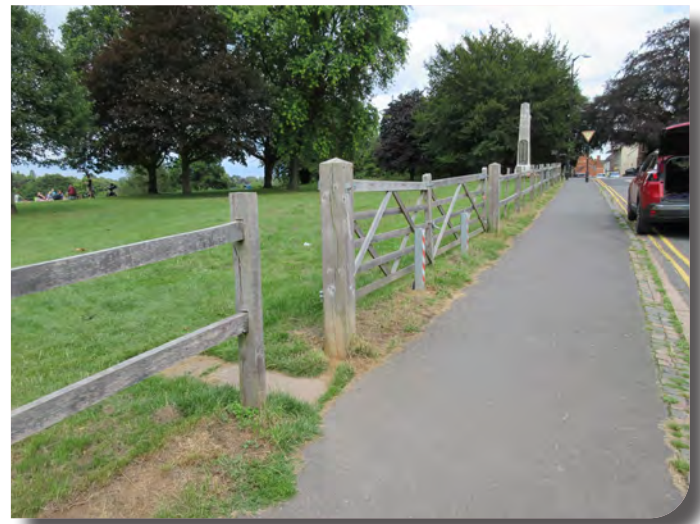
War memorial informal opening

Paving slabs are used to control erosion. There is no signage, however, this location is in close proximity to the War Memorial entrance.

An informal timber chicane pedestrian access enters the Fields through the fence along the lower end of Forrest Road. Erosion has been managed with use of paving slabs, although wear is noticeable at the intersection with the mown grass causing a potential trip hazard. The access point would not be suitable for wheelchair access.

- **Geocell mats could be used to control erosion or periodic closure for repairs to the erosion could be introduced.**
- **Informal signage of entrance to the Fields.**

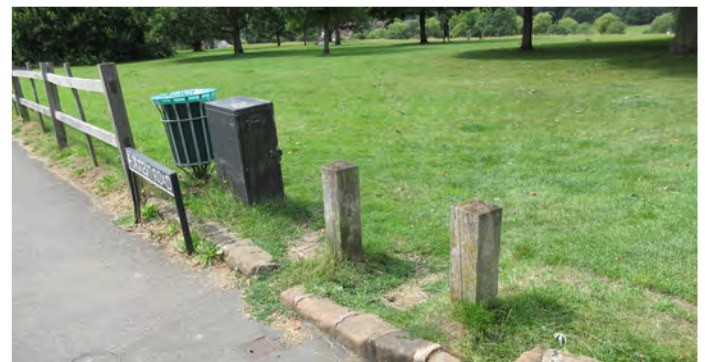
Further east along Forrest Road an informal opening is located adjacent to double field gates.

A wide informal gap in fencing with timber bollards, utility cabinet and a bin is located west of the War memorial. This allows for informal access onto the higher ground of Abbey Fields. A raised stone kerb restricts less able bodied access.

It appears that this opening may have been created to reduce pedestrians trampling on the bedding plants around the war memorial.

- **Make the access level with the footway to create a more accessible informal entrance.**
- **Replace all bollards in line with the Design Guide**

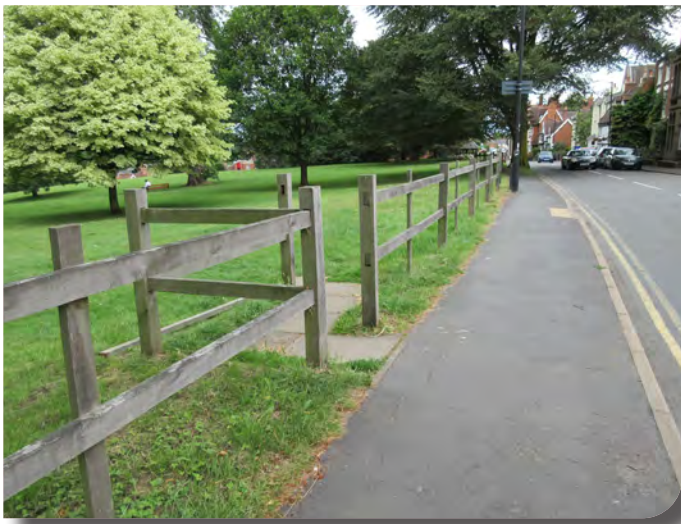
An informal timber chicane pedestrian access enters the Fields between the bus shelter and Holmes Avenue. It is located opposite Southbank Road. Erosion has been managed with use of paving slabs although they have some subsidence. The fence line here is broken. It doesn't appear to be a well-used entrance.

- **Repair the fence and level the paving slabs**
- **Make necessary repairs should erosion become a problem.**
- **Encourage pedestrians from Southbank Road to use the Abbey Hill shelter entrance or War memorial entrance with improved signage and permeability across the main road.**

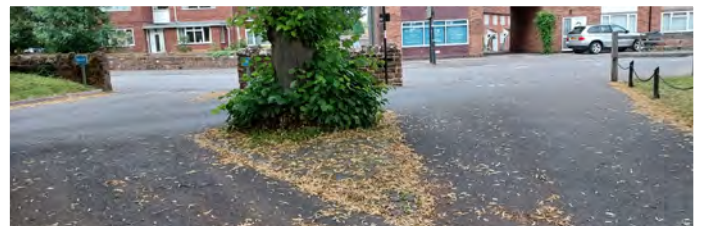
Formal vehicle access is via the car park entrance off Bridge Street. Signage for parking is provided from the town centre and adjacent to the car park.

There is substantial conflict between cars entering and exiting as well as between cars and pedestrians as they all share the same driveway.

- Consider alternative options for access into the main Drive to improve pedestrian permeability.
- Consider passing places along Main Drive for safe refuge for pedestrians when vehicles use the main drive.
- Access to the car park would benefit the provision of a separate pedestrian footway and signage to warn of shared access with a 'Give way' from the car park to incoming vehicles. Rumble strips would slow vehicles entering the car park.
- Consider a passing place at the entrance to the Fields to reduce conflict between vehicles.

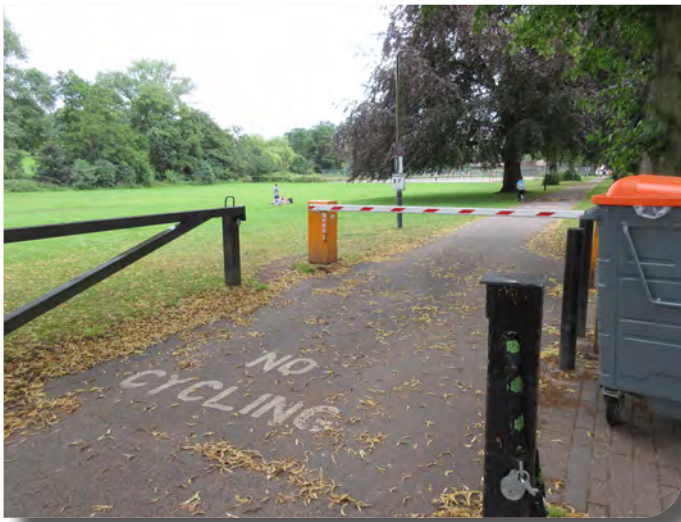
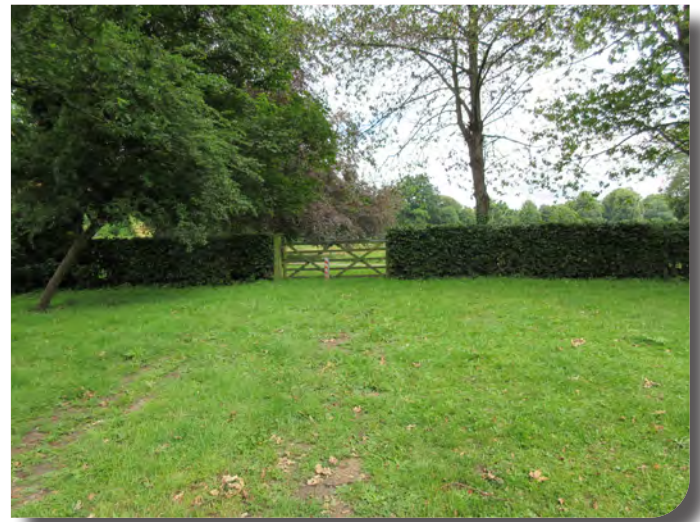
The leisure facility has a lockable vehicle barrier and an automated vehicle barrier. The lockable barrier is believed to be used when concerns are raised over potential traveller incursion. Pedestrian access remains feasible with a block paved bypass to the barriers. However, pedestrian access is regularly impeded with storage of the Leisure Centre's commercial bins.

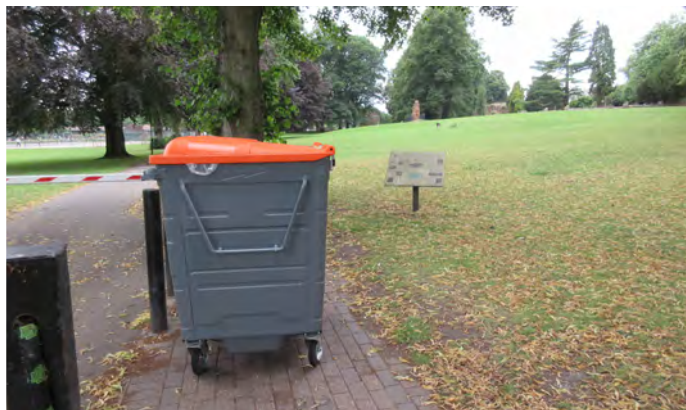
There are multiple field gates that are located around Abbey Fields that provide maintenance access to the Fields. These are all protected by lockable bollards to prevent unwanted access. Maintenance access is good, although there are differing styles of gates and conditions noted around Abbey Fields, discussed in more detail in the infrastructure audit.

- All field gates should be replaced as and when required, in the style of the Design Guide.

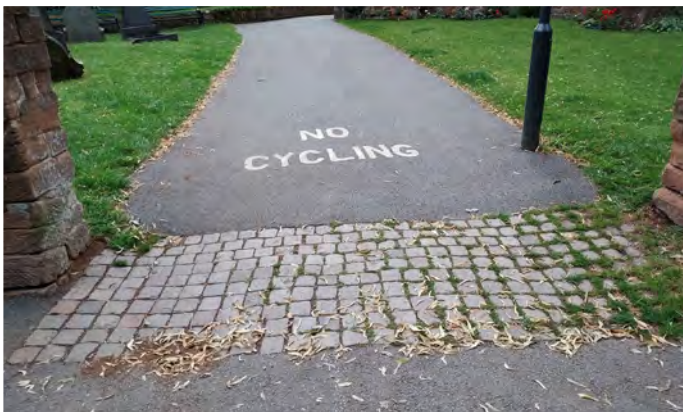
Church & Abbey

Church Walk leads up to St Nicholas church and is a wide, lime tree-lined path with tarmac in good condition. Access into the churchyard is clearly demarcated with stone cobbles in line with the churchyard walls. The cobbles are showing signs of subsidence where vehicle movement has tracked them. Grass is growing through the sets which is acceptable but may destabilize them in time. 'No cycling' is marked on the access to the church and does detract from the quality of the churchyard experience.

Tarmac around the church is of different grades and quality although the surfaces are in reasonable condition.

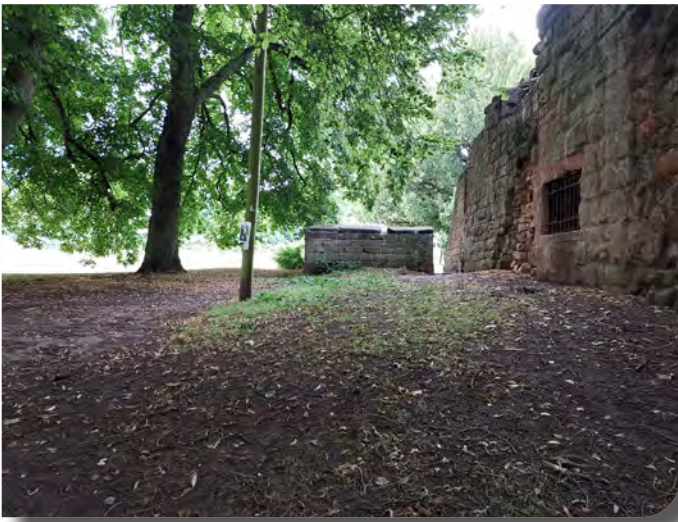
The Gatehouse ruin within the churchyard has substantial pedestrian erosion around its base with desire lines through the churchyard, past the ruin. The paths around the base of the Gatehouse ruin have deteriorated resulting in hardcore becoming visible with some trip hazards of foundation stones and stones within the ground.

- **The paths around the base of the Gatehouse ruin need to be repaired with a new surface, such as Breedon gravel. This will not only reduce trip hazards but provide a higher quality experience of the ruin and encourage pedestrians to walk through the ruin.**

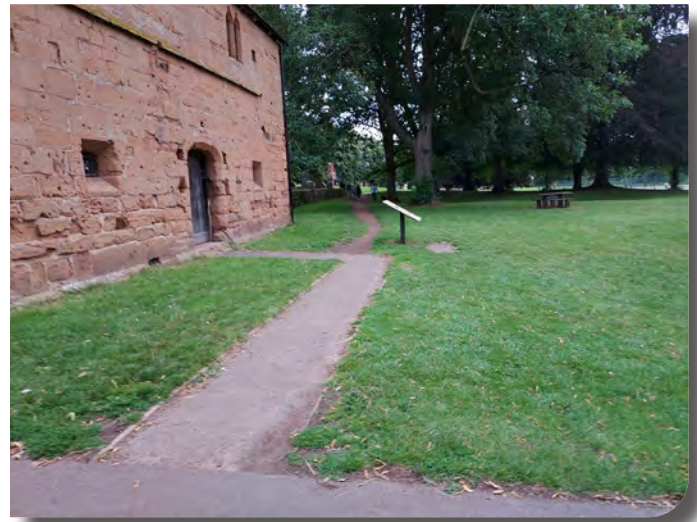
Tarmac paths that lead from the Gatehouse south and west are covered in leaf litter and have not been maintained. The condition of the paths is unknown with encroachment of grass verges leading to the paths narrowing. Tree branches are low and overhang the paths and the Gatehouse creating dense shade.

- **All tarmac paths would benefit resurfacing to improve the user experience.**

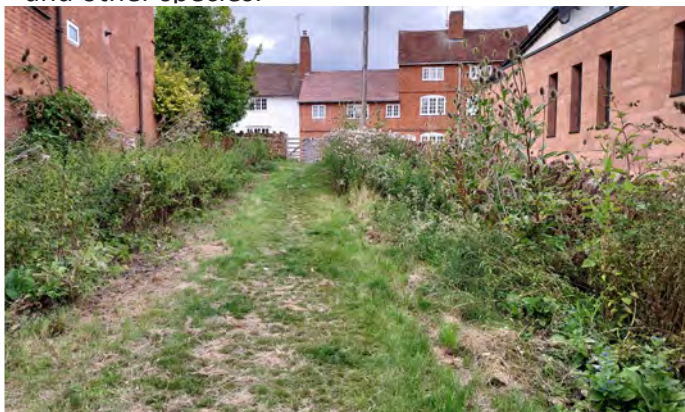
An historic, informal mown grassed path leads south from High Street and adjacent to the churchyard wall. It has tall, wild margins that include bramble, nettle, common thistle, teasels and other species.

Alongside the garden boundary to the west, large native shrubby trees are overgrown. The wildlife margins, although of high value, are encroaching onto the mown path, resulting in the path becoming narrower. The wildlife margins are important and need to be balanced with a decent path width to prevent the path become narrower, impassable, or difficult to negotiate.

- **Brambles, nettles, thistles and shrubs along boundaries to continue to be managed on a 1 in 5 rotational basis. Wildlife margins should be encouraged, but encroachment on seating areas and paths needs to be monitored. If required a 1m buffer around seating should be maintained.**
- **Managing eroded areas could be undertaken on a rotational basis to encourage grass regrowth. Formalising path connections to the lakeside would reduce bank erosion between the bank and the lake.**
- **Set all benches within a tarmac and surfaced base that ties into the formal path surfaces. If benches are located within a grassed margin, erosion management will be required around the bench base.**
- **Consider widening the main path to 2m in line with Warwickshire County Council Rights of Way and Recreational Highway Strategy 2011-2026, Policy RW5c.**
- **All tarmac paths would benefit resurfacing.**

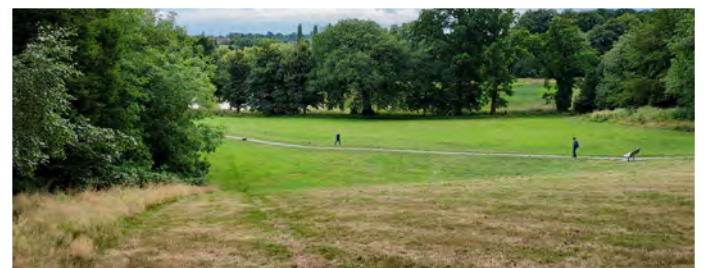
A tarmac path leads from High Street (north west of the Fields) and connects with the churchyard at The Gatehouse ruin. This is a very narrow, steep path, but is well used. There is much erosion either side of this path as it is too narrow to take the volume of footfall. It also forms part of the Centenary Way. There is significant erosion around the bin and bench at the top of the hill.

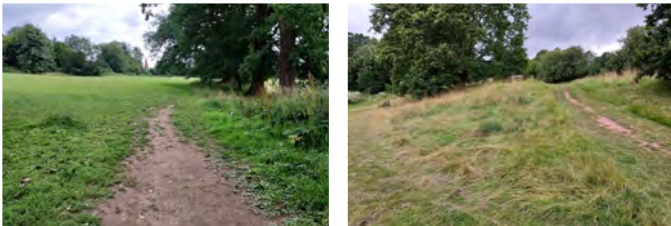
Informal paths lead around and through the western woodland. Through the woodland the path is well worn, narrow and undulating. Both paths meet the hardcore path that connect to the lakeside.

From the hardcore path an informal path follows the line of trees at the bottom of the bank and connects through the tree line to the lake, and also to the Gatehouse ruin. There is much erosion at the interchanges between the paths.

Benches located throughout this area have substantial erosion to their base and in some instances are no longer the recommended height for seating and footings are visible. Some are enveloped in brambles and difficult to utilize.

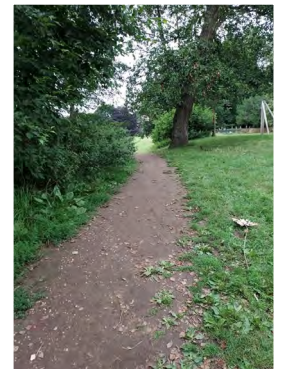
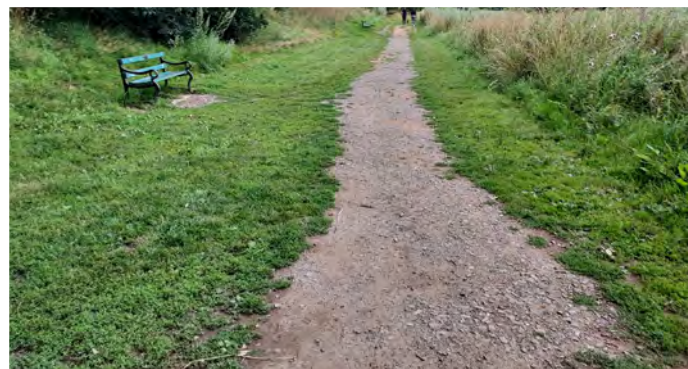
A compacted hardcore path leads north from the tarmac entrance on Castle Road along the western margins and northern edge of the Lake. It has substantial footfall with erosion to the edges of the path.

Castle Road towards the leisure facility. This runs between the lake and Finham Brook. The path does not appear to be wide enough for the volume of pedestrians who use it as there is much erosion to the path edges although its width allows two prams to pass each other easily. The condition of the path is generally good, with some signs of subsidence. A mown path connects this tarmac path, through the meadow to the other side of the lake.

- **All tarmac paths would benefit from resurfacing.**

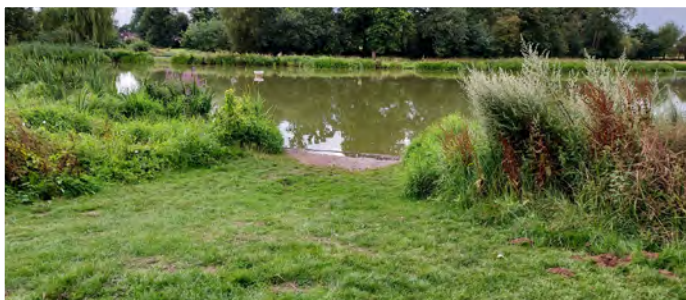
Access to the lake has been limited with hidden fencing, which has controlled the areas of erosion. There are two beach areas that encourage interaction with the lake.

The duck feeding station at the leisure facility is a decked platform over the lake. It is easily accessible for all pedestrians from the leisure centre and the lake. The southern lakeside edge leading up to this platform has substantial erosion to the surface and also to the embankment.

- **Consider creating a hard surfaced graded slope into the lake at the north side to replace the timber sleepers to provide high quality interaction with the lake. Introduce positive notices encouraging the safe use of the lakeside beaches to reduce pressure elsewhere. Continue fencing in more sensitive locations to restrict dog ingress into the water's edge.**

- **Consider use of alternative structural supports, to prevent undercutting of the lakeside.**
- **Replace and extend duck feeding station with a solid structure to remove erosion issues.**

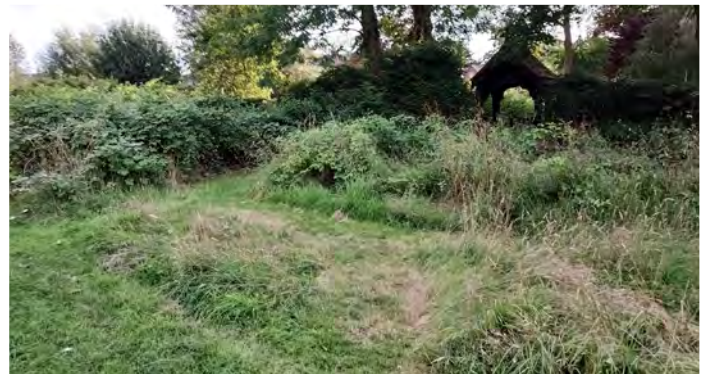
There are a number of locations along Finham Brook where dogs and pedestrians have caused erosion to the embankments, although erosion along the southern bank is not as critical as the northern bank with the lakeside.

- Entrance erosion is detailed in relation to Primary Access points
- A formal tarmac path from Castle Road would reduce erosion and improve accessibility to this area of the Fields.
- Rotational erosion control at pinch points should be considered to ensure trip hazards are managed and grass recovers.
- Access to Finham Brook should be controlled where possible with vegetation to limit erosion by dog access/egress.
- Consider fencing the mound along Finham Brook to prevent access for safety reasons and to reinstate it to grass.
- Brambles, nettles, thistles and shrubs along boundaries to continue to be managed on a 1 in 5 rotational basis. Wildlife margins should be encouraged, but encroachment on seating areas and paths needs to be monitored.
- All tarmac paths would benefit from resurfacing.
