VISITOR ACCESSIBILITY

ACCESS AUDIT

The Access Audit assesses the quality of access within and to the Fields in terms of its visibility, legibility and accessibility for both able bodied and less abled bodied users and is supported by the Access and Circulation Plan. The audit has looked at the following:

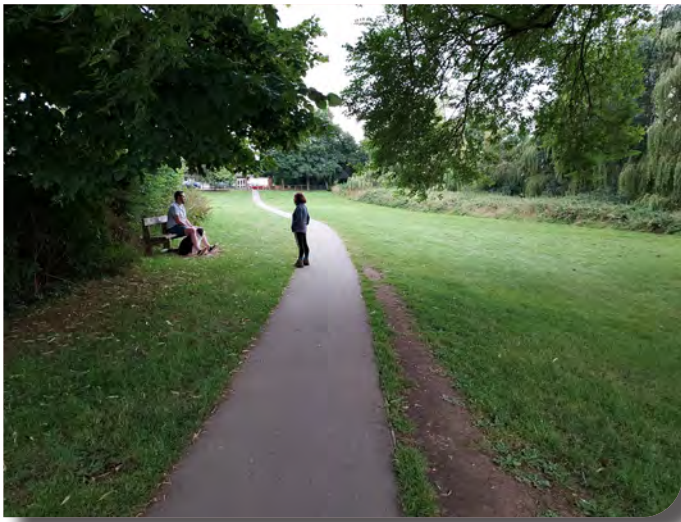
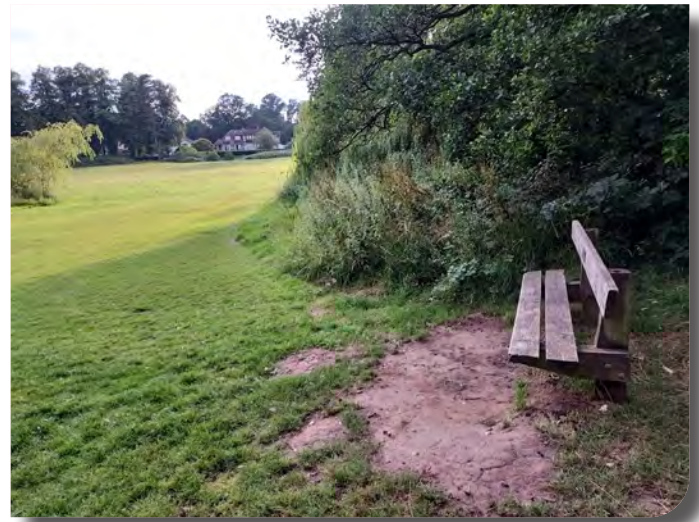
A very well used formal tarmac path leads from Borrowell Lane and connects with the lake and the leisure facility via two bridges over Finham Brook. However, the path is narrow with erosion along the western edge as it is bound to the east with a wide

mature hedgerow. Mature trees are also dotted along this path potentially restricting its width in parts.

- Entrance erosion is detailed in relation to Primary Access points
- A formal tarmac path from Castle Road would reduce erosion and improve accessibility to this area of the Fields.
- Rotational erosion control at pinch points should be considered to ensure trip hazards are managed and grass recovers.
- Access to Finham Brook should be controlled where possible with vegetation to limit erosion by dog access/egress.
- Consider fencing the mound along Finham Brook to prevent access for safety reasons and to reinstate it to grass.
- Brambles, nettles, thistles and shrubs along boundaries to continue to be managed on a 1 in 5 rotational basis. Wildlife margins should be encouraged, but encroachment on seating areas and paths needs to be monitored.
- All tarmac paths would benefit from resurfacing.

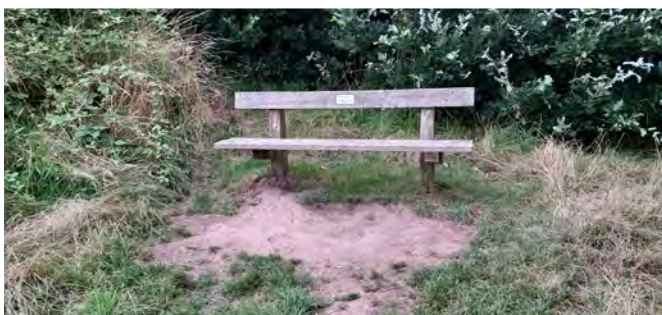
There are also a number of interconnecting informal paths that lead through gaps in the hedge and into Hillside with substantial erosion and potential trip hazards where they meet the tarmac edging.

Benches located throughout this area have erosion to their base and in some instances are no longer the recommended height for seating and footings are visible.

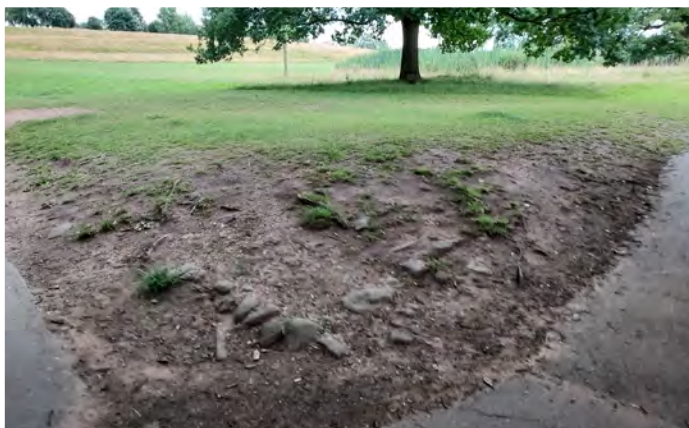
Where the paths meet at the base of Hillside, there is considerable 'corner cutting' erosion exposing stone from the Mill ruins.

- **The informal path at the top of Hillside that links Holmes Avenue with the war memorial path would benefit formalising into a tarmac path. Tree roots would need to be considered in its construction and alternative structures used if required.**
- **Holmes Avenue would benefit some crown lifting. Epicormic growth is undertaken once per year, but with climate change it has been noted that epicormic growth is becoming a problem later in the year. It would be beneficial to undertake a biannual removal of growth to ensure access is not restricted or oppressive.**
- **All tarmac paths would benefit resurfacing.**
- **All areas of substantial erosion could be managed with rotational reinstatements to encourage grass recovery or more formal entrances created.**
- **Consider fencing of the Mill area to protect the ruins.**

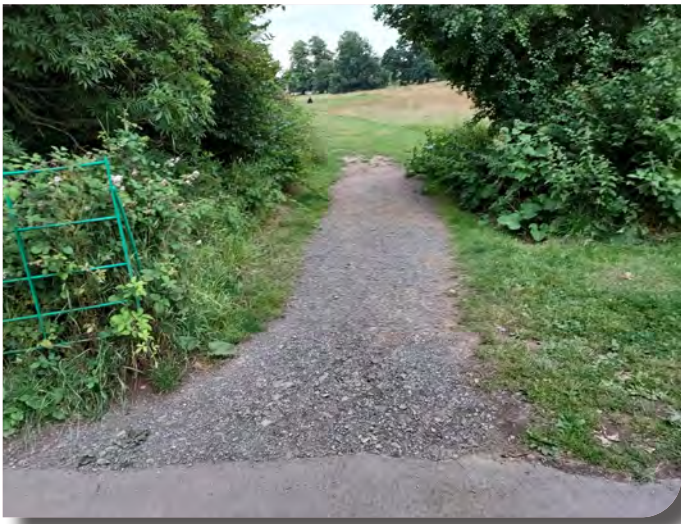
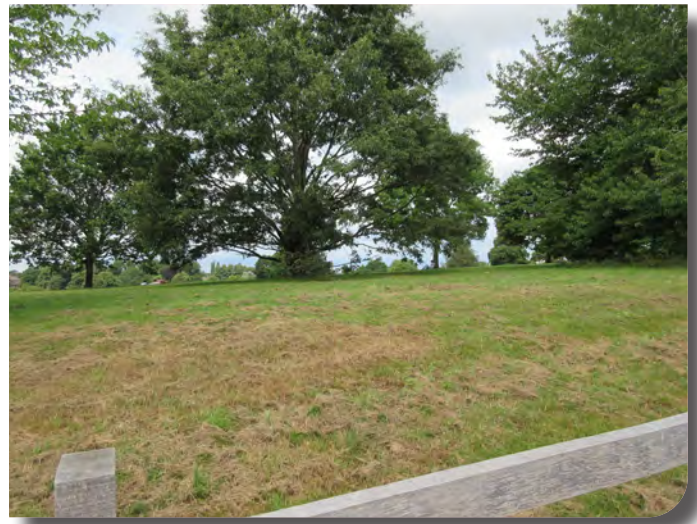
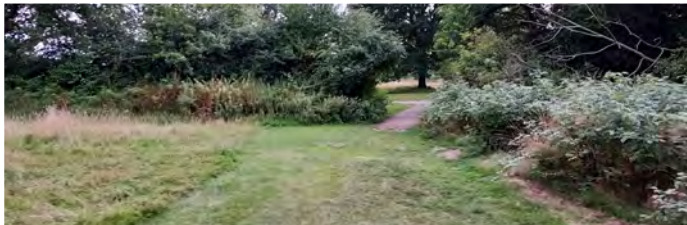
Meadow areas with mown paths provide additional popular routes around Hillside, with gaps in the hedgerow along the Abbey Hill path to connect through from South Brook to Holmes Avenue. However, this has caused substantial erosion points, with trip hazards adjoining tarmac. In some instances compacted hardcore has been used to control erosion. Informal paths at the base of Hillside suffer erosion at locations where water collects.

A timber bridge at the bottom of Hillside crosses Finham Brook and connects into the play&leisure zone towards the car park. This is well used with substantial erosion to its base.

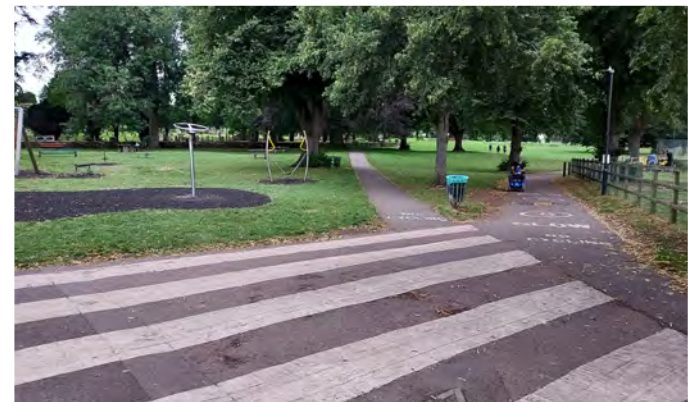
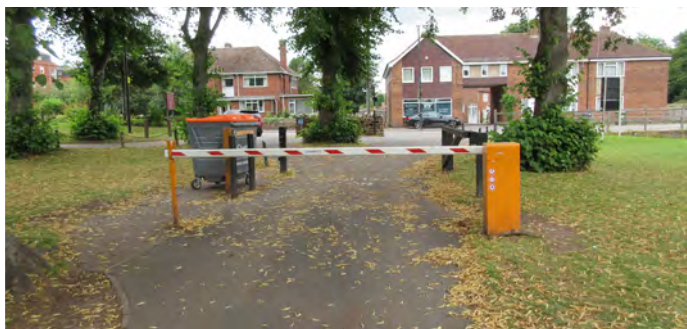
The main drive is a vehicle and pedestrian shared path. It is the main pedestrian path from the car park to the play area and leisure facility. It is also used by delivery and disabled vehicles accessing the leisure facility. The main drive has conflict between vehicles and pedestrians along its entire length with overrun caused by vehicles on soft verges avoiding pedestrians particularly in poor weather conditions.

A fenced play space for younger children is located to the south of the drive and an unfenced play area for older children to the north. The main drive and turning space bisect the play areas with a large zebra crossing painted on the ground. However, children are continually traversing this driveway

The driveway has a speed limitation of 5mph painted on the ground. Speed bumps are located at intervals along the path.

- **Pedestrian safety along main drive is a priority. Suggestions for improving safety include,**
 - » **more severe speed bumps,**
 - » **rumble/cobble strips,**
 - » **Auditory announcements at the entrance to advise drivers of speed limit, to turn on hazard lights, and to give way to pedestrians.**
- **Redesign the layout of the parking and vehicle arrangement at the entrance to the new leisure facility to reduce potential conflict.**
- **Provide passing places for safe refuge of pedestrians when vehicles access the main drive, and also to remove the overrun and rutting of the Fields during wetter months.**

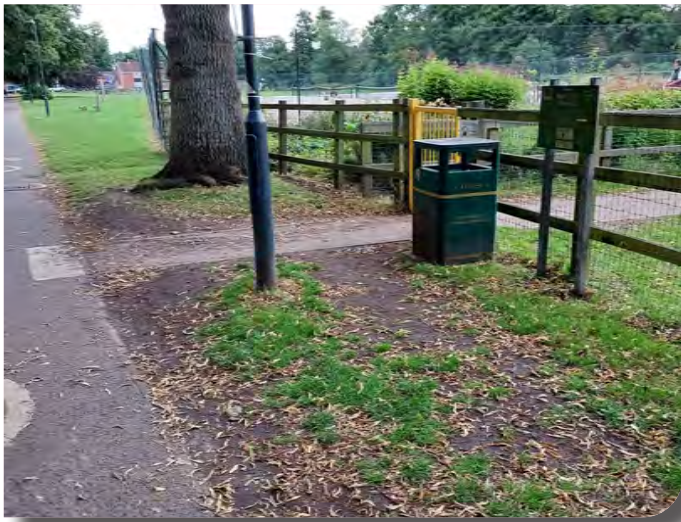
However, it has been witnessed that drivers often do not adhere to the speed limit. The path condition is generally good, although there are small areas of wear to lawned areas from mobility scooters avoiding the speed bumps, and vehicles passing along the length.

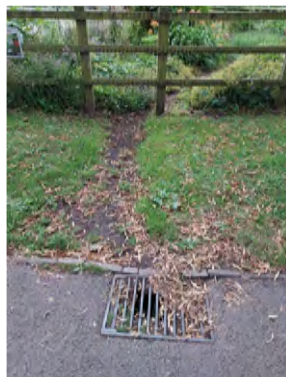
Fenced play

Tarmacked access to the eastern gate of the fenced play space is muddy. Muddy erosion extends to both sides of the path particularly as it joins the driveway. Drainage appears to be an issue in this area. There is a rain garden located a few metres away from this entrance.

- **The eastern entrance path would benefit being widened and chamfered to the driveway.**
- **Potential to improve drainage in this location directing water towards the rain garden gully.**
- **Annual inspection of resin bound paths is required to ensure that the edging wear and cracking does not create holes and trip hazards. Repair of paths required as and when needed.**
- **Mown access paths to the meadow with benches and wild play should be mown at least fortnightly to maintain firm footing for children to explore the meadow.**
- **The play facility will require substantial improvement within the next 10 years. However, repair/replacement of broken structures is of high importance to improve the accessible experience of children in this play space.**

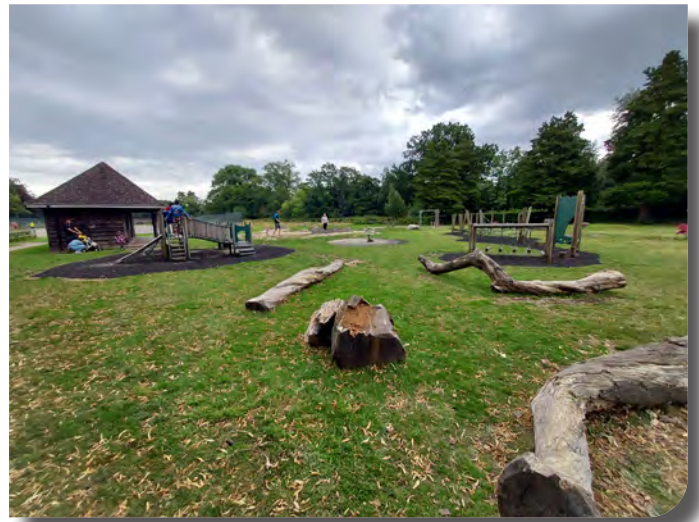
The mown access paths to the meadow appear to have missed a regular mowing regime. Brambles are also encroaching the mown path along the hedgeline boundary. Some of the play structures have rotted but are still accessible, and some

formal play structures have been fenced off due to unsafe structures.

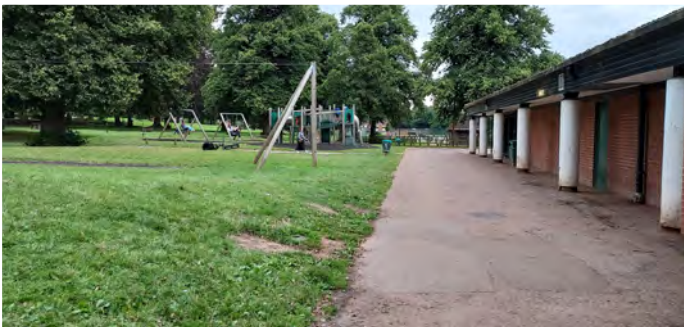
Leisure facility

Access to the leisure facility is good and level, although unattractive. Parking of disabled vehicles and trailers in this location inhibits movement around the leisure facility. There is concern over conflict of vehicles with many pedestrians using this space.

Level areas of tarmac around the leisure facility allow for skateboarding which can cause conflict with other users.

The leisure facility is due to be improved and access to and around this facility needs to be incorporated into the design layout.

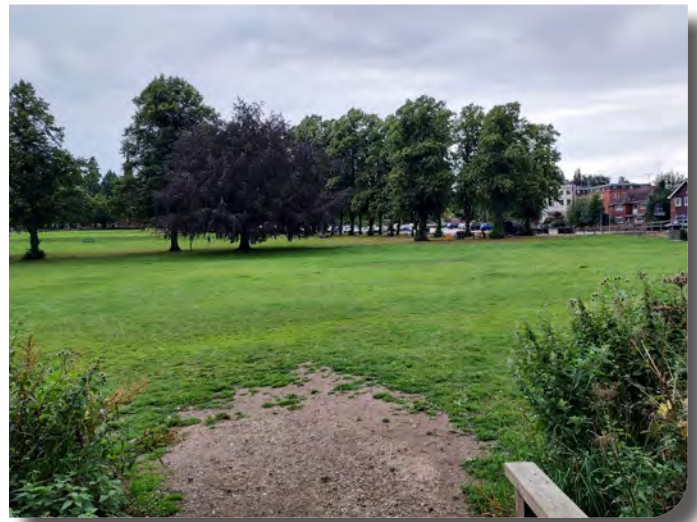
Tennis courts

Formal access to the tennis courts is through the fenced play area with subsidiary access from the eastern boundary. The surface of the tennis courts is basic tarmac. Access to retrieve balls outside of the tennis courts is via the main entrance within the play space, and also the subsidiary entrance.

- **In alignment with the Final Playing Pitch Strategy Assessment Report, June 2019, Abbey Fields tennis courts are classed as poor quality, conflict with netball and require refurbishment. Recommend refurbishment following leisure centre development.**

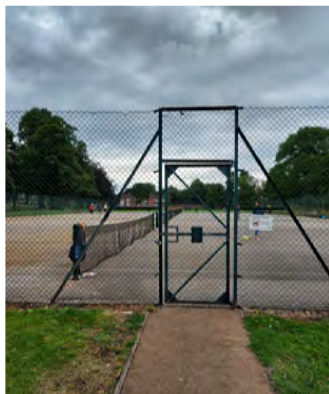
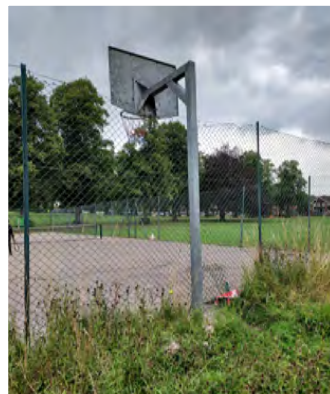
Fairground field

The fairground field is located to the east of the tennis courts with informal footpaths that cross the field leading to/from the car park, and also under Bridge Street. The field is easy to access.

Basketball/netball posts are located to one end of the tennis courts with shared court use.

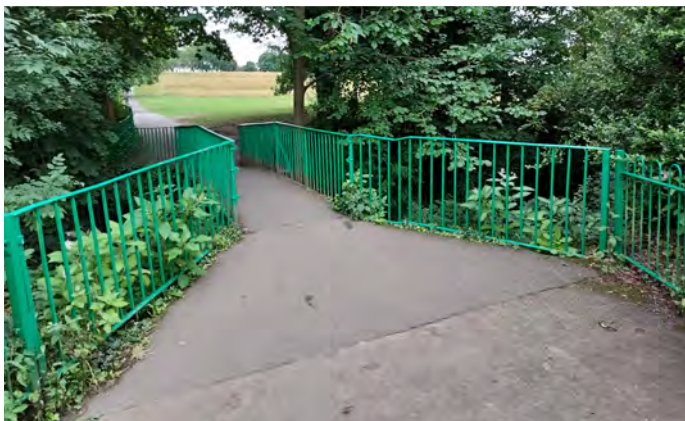
Informal footpath

An informal footpath runs from Bridge Street between the fenced play area and Finham Brook leading to the iron bridge adjacent to the leisure facility. This path can be boggy during wetter periods, with steep sides down to Finham Brook.

- **Ensure this path continues to link with the proposed leisure development. Plans appear to show it as being permanently closed off.**

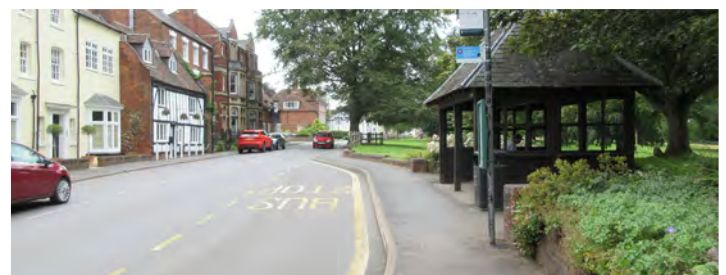
Bus

There are numerous bus stops located around the Fields although there are no bus stops along Borrowell Lane or Forrest Road. A small bus station is located at the south of Abbey End with maps identifying its proximity to Abbey Fields.

- **Work with Kenilworth Town Council (KTC) alongside their Wayfinding Strategy and in line with the Fields Design Guide to ensure that Abbey Fields is clearly signposted with finger posts visible from the bus station.**
- **To provide entrance signposts at all entrances to the Fields such that pedestrians are welcomed into Abbey Fields from the bus stops.**

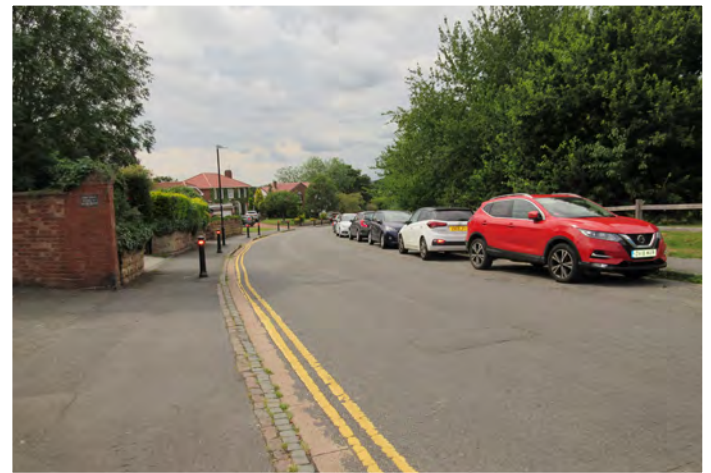
Roads & Access

Abbey Fields is well served by major and minor roads, although Abbey Fields Car Park is the only aspect of Abbey Fields signposted to road users. There are many visitors by car to the adjacent Kenilworth Castle and these are signposted with brown signs and English Heritage markers. On road restricted parking is also available on High Street and Abbey Hill, with unrestricted parking along Forrest Road.

The Fields is surrounded on three sides by walkable residential areas and there are many visitors who access the Fields on foot.

- Consider use of Brown Signs to direct visitors to the Fields (similar to Kenilworth Castle)
- Pedestrian safety to a destination green space is priority considering the increasing number of people using this green space following Covid 19. Undertake a Traffic Management Review to consider and implement, in partnership with others such as English Heritage, traffic safety measures to reduce the conflict between moving traffic on busy main roads and pedestrians accessing and egressing the Fields via Kenilworth Castle and the Town Centre. Particular emphasis on Castle Road, Rosemary Hill and Abbey Hill
- Work with KTC with regards their Wayfinding Strategy in line with the Fields Design guide and ensure finger posts identify the length of time for walkable links to the Fields.
