INFRASTRUCTURE AUDIT

ABBNEY FIELDS INFRASTRUCTURE AUDIT 2021

The infrastructure audit focuses attention on all the existing infrastructure i.e. furniture and shelters etc within Abbey Fields, looking at their condition, their legibility, their function and their consistency. Further to the audit, a series of recommendations identify improvements that can be made over time to the infrastructure within Abbey Fields, for example, uniformity of furniture, clearance of clutter, cleaning furniture etc. These have then been fed into the Actions for the Fields. The audit has been prepared identifying the infrastructure within each zone within the Fields.

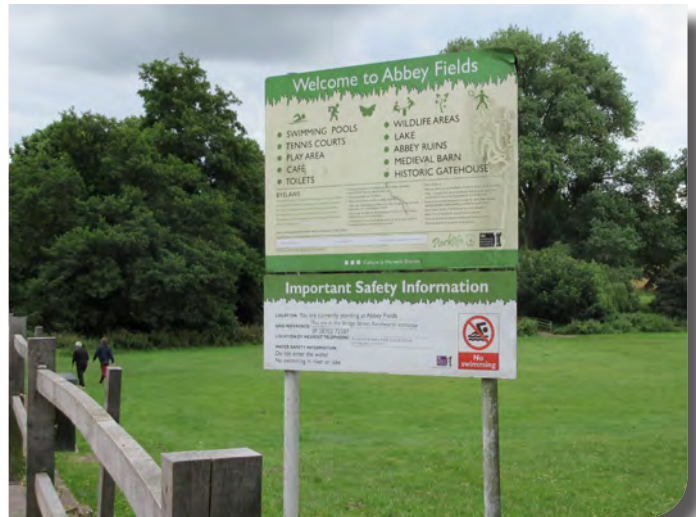
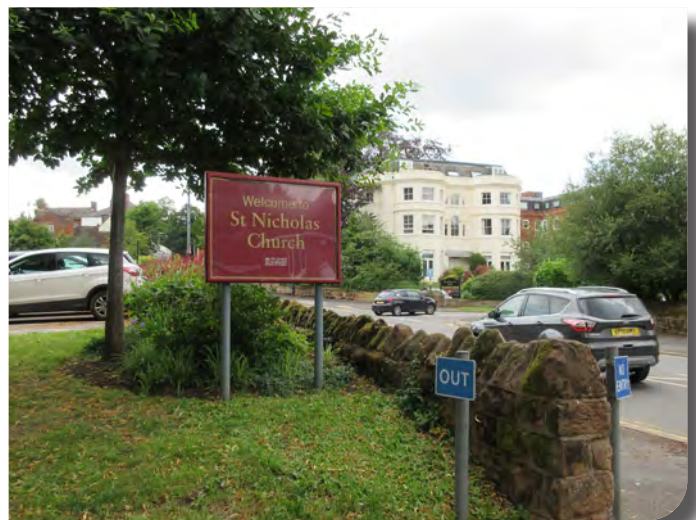
The welcome sign to Abbey Fields is too small, faces only one way on Bridge Street, and holds far too much information. It cannot be read by vehicles as the main welcome typeface of cream on green disappears and the rest is too small to be read from a vehicle. It appears to be a welcome sign for pedestrians in a location not readily accessed by pedestrians, except for those on the pavement. However, the pavement has low footfall as access to the Fields is generally under Bridge Street or via other entrances. In contrast, the welcome sign to St Nicholas Church is bold and clear, if a little dated.

2. **Change the welcome sign to the Fields and have a double fronted bold sign to face both directions of the Bridge Street.**
3. **News and events board to contain only information pertinent to news and events and not on rules and regulations of the Fields. The information needs to be much bolder and clearer to read. Refresh printing regularly where it fades in sunlight.**

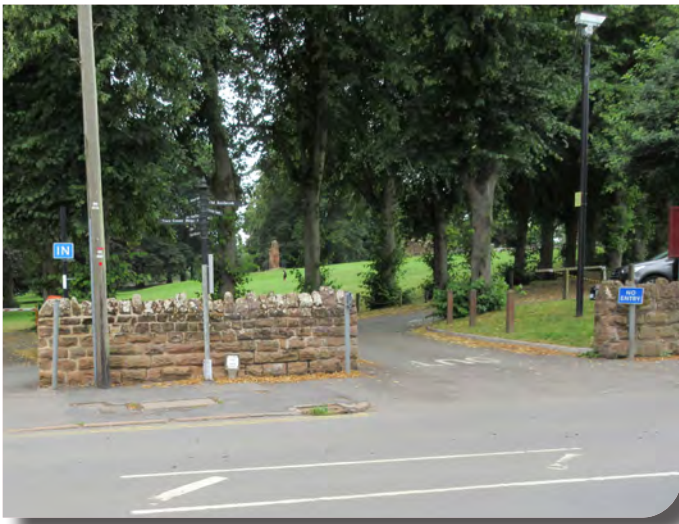
The entrance and exit from the car park along Bridge Street have 'in' and 'out' and 'no entry' signs. However, there is a great deal of clutter at the entrance with left over posts of past entrance signs that were never removed. New signs have been put in place behind these and altogether make the entrance look untidy.

1. **Tidy up the main vehicle entrance by removing all unnecessary poles and ensuring 'in', 'out' and 'no entry' signs are at the same level and clearly visible. These would benefit being affixed to the wall as opposed to poles to improve the overall appearance of the car park entrance.**

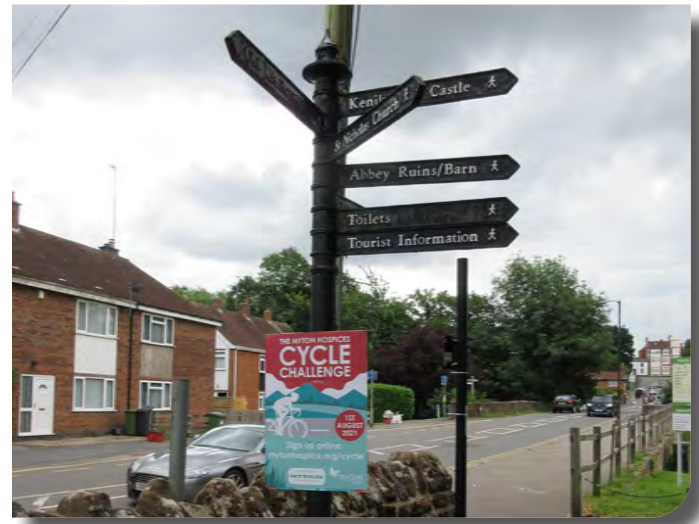
Car park signage with a different welcome sign and two pay at machine signs. The machine signs are convoluted, with too much information, too many blocks of signs on one notice board that only relate to the car park payment system.

4. **Parking signage to be recessive to the Fields welcome signage. The parking signage needs to be more concise and less cluttered.**
5. **Have Welcome signs to the main pedestrian Fields entrances that provide a Fields map, information, do's, with some important don'ts to create a positive welcoming feel to Abbey Fields from the car park.**

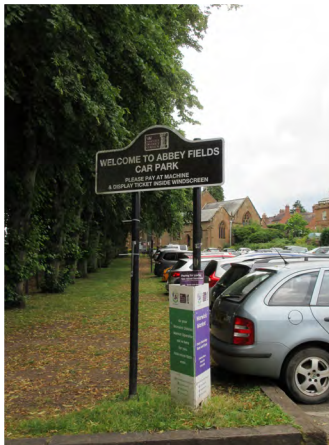
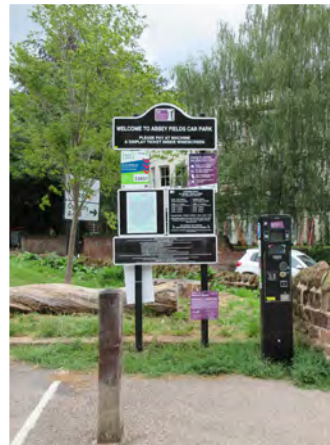
A dated fingerpost for the Fields has been placed in a poorly accessible location and one that is easily missed by pedestrians as it is within the main vehicle entrance to the car park, not used by pedestrians; painted black, it is easily missed. The fingerpost is generally not seen until you leave the car park by vehicle or leave the play facility/Leisure Centre along the Main Drive. The fingerpost does not direct to the Leisure Centre, play area or the lake, key features of the Fields.

6. **Bollards and bins to be all of one style throughout the Fields and regularly cleaned.**
7. **Fingerposts to be located in visible pedestrian locations and be of a modern style but not stainless or brushed steel as this is not the character of the Fields.**

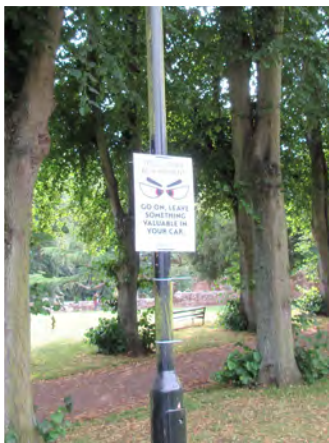
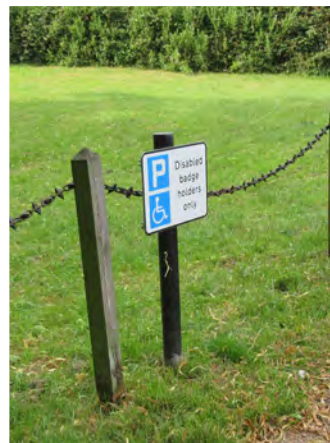
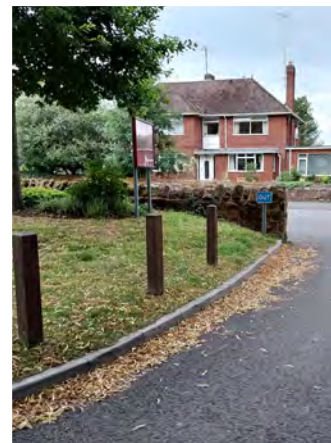
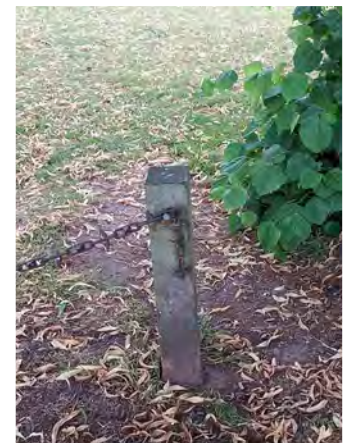
There are bollards of different styles located in the car park. They are all made of timber but vary in style. Consistency of bollards throughout the entire Fields is important.

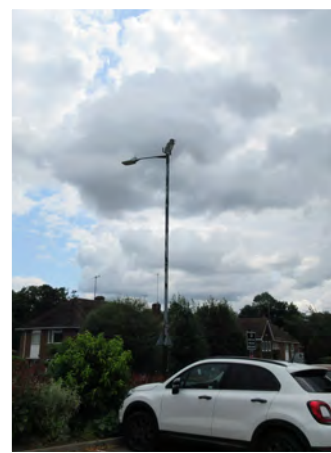
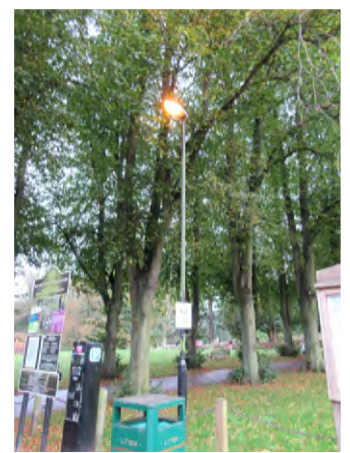
Lighting of the car park is from flood lights located to its perimeter, one of which is shared with a street lamp. A street lamp is also located adjacent to Church Walk and is permanently on, presumably because it is located under trees at the pay station near to the pedestrian entrance to the Fields. The sustainability aspect of these lights needs to be considered.

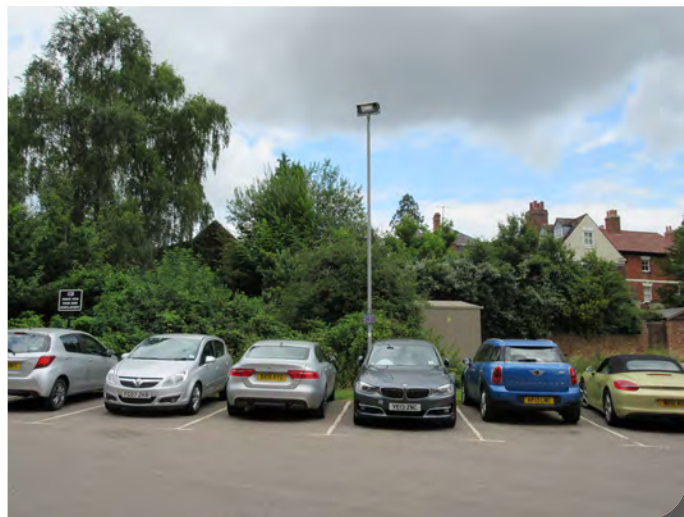
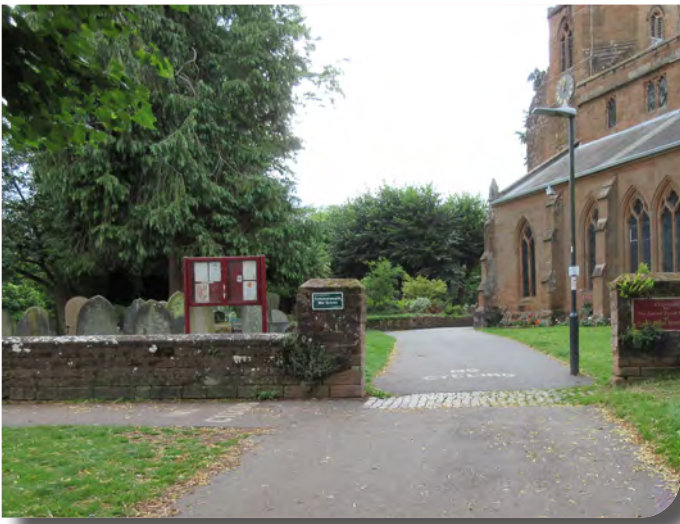
The car park entrance lacks definition as the main entrance to Abbey Fields and is degraded by additional fly posters and signage clutter some of which could be located within the noticeboard.

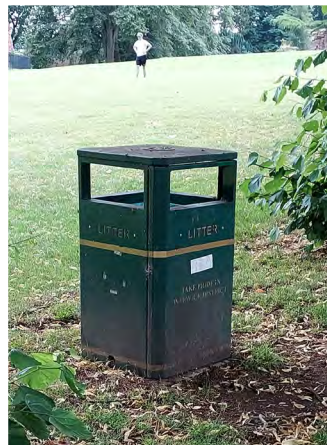
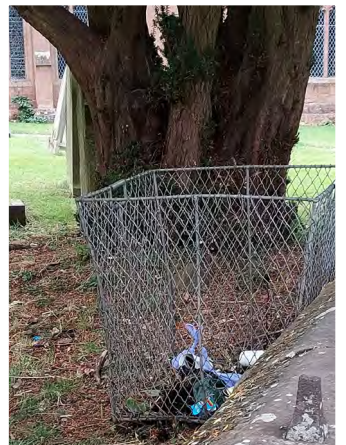
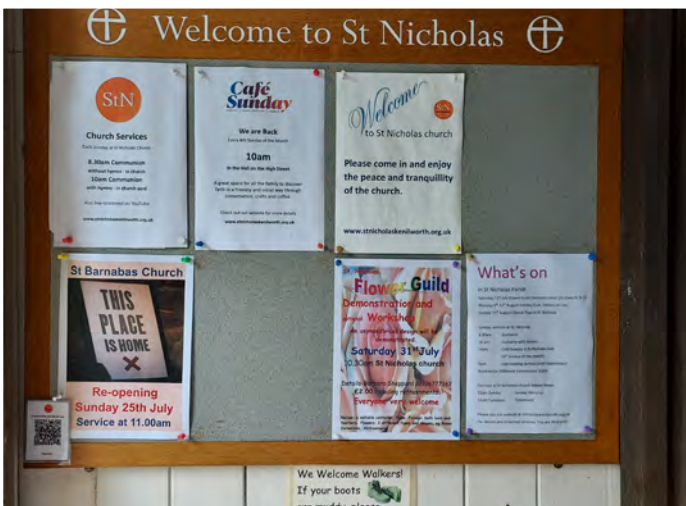
Bins vary between the church and the abbey ruins area. Standard mesh bins are used within the churchyard and amenity bins are located elsewhere. The amenity bins are soiled. Both bins have erosion to the ground around them from substantial use.

3. Bins to be cleaned and located next to footways to reduce erosion. Ensure consistency of bin styles throughout the Fields, confirmed in the design code. Mesh bins should be replaced within the cemetery and consideration of sustainability encouraged to reduce plastic waste, with green waste recycling for flowers.

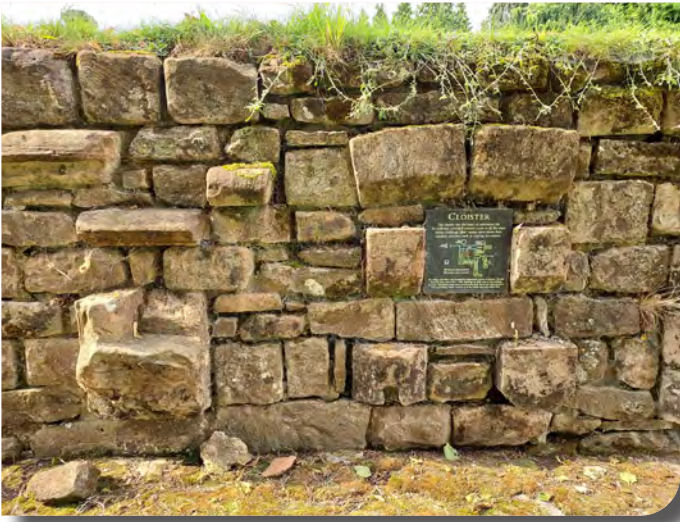
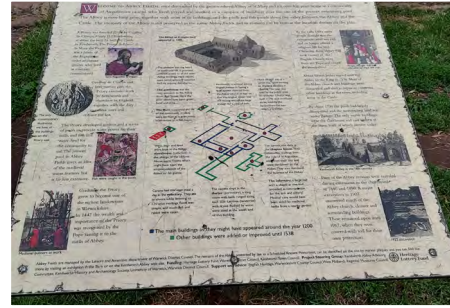
Historical information signage on the Abbey Ruins is complementary but can appear too discrete, too high and sometimes can be missed. Reading the information from a distance, at height or when the panels are soiled or in the ground can be difficult.

4. Historical information signage to be cleaned and made more accessible/visible. This may require small lecterns or posts.
5. Refix the dated plaque to the Gatehouse ruin.

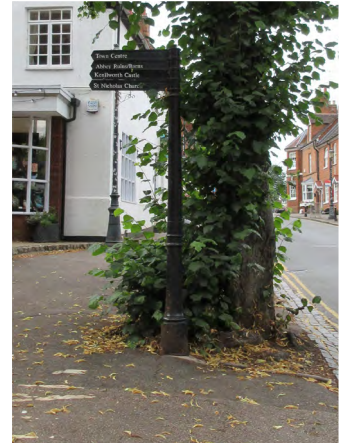
A dated finger post located near to the primary entrance of the church off High Street has no information in relation to the Fields. It is dark and hidden within the confines of a mature tree.

9. Fingerposts to be located in visible pedestrian locations and be of a modern style but not stainless or brushed steel as this is not the character of the Fields.

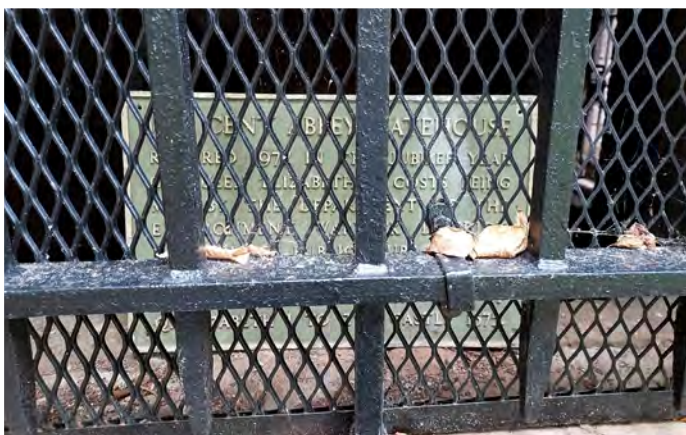
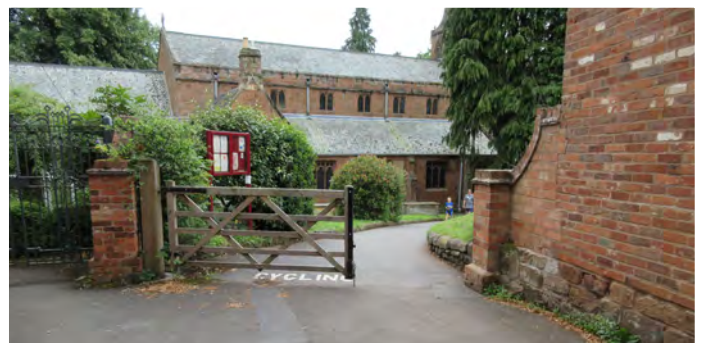
The gated access off High Street appears to be a double leaf gate although the pedestrian gate is purposefully missing. However, it is not noticeable and allows open pedestrian and disabled access but restricts vehicles. The style of the gate is in keeping with the Fields and the wider area.

A plaque from the Gatehouse detailing dated information is not visible as it is located behind security bars. Relocating this on the building would be beneficial.

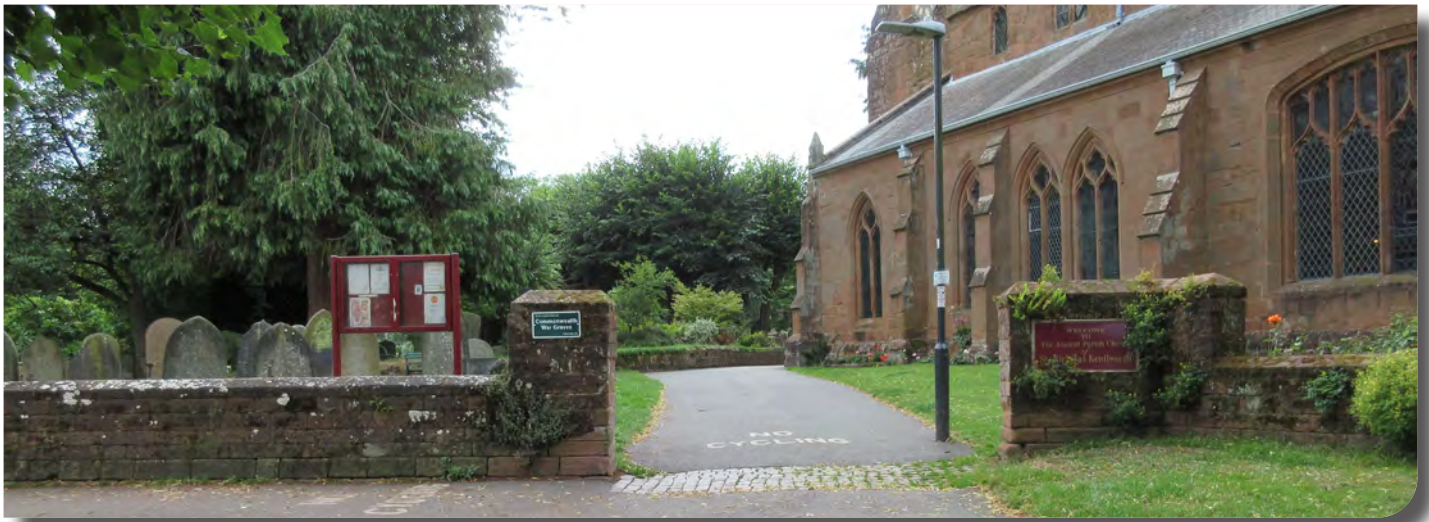
Other signs include dog fowl signs, Garden of Remembrance and security/safety signs. The garden of remembrance sign is loose and not set into the ground. The safety signs are very clear, although do detract from the ruins.

Access infrastructure elsewhere jars with the historic elements of the Church, Abbey Fields, and High Street.

6. Ensure all signage within the cemetery is not loose and is located appropriately.
7. Improve legibility of the Abbey Ruins particularly around the church. A lectern of information would be of benefit near to the main church entrance.

10. Access 'A' frame gate to Church Walk to be replaced with more appropriate, less visually intrusive gates, although with some reflective capacity.
11. Determine whether the safety roadside barrier on High Street would be required following works to hedges. If required, consider replacement with more 'artistic' design.

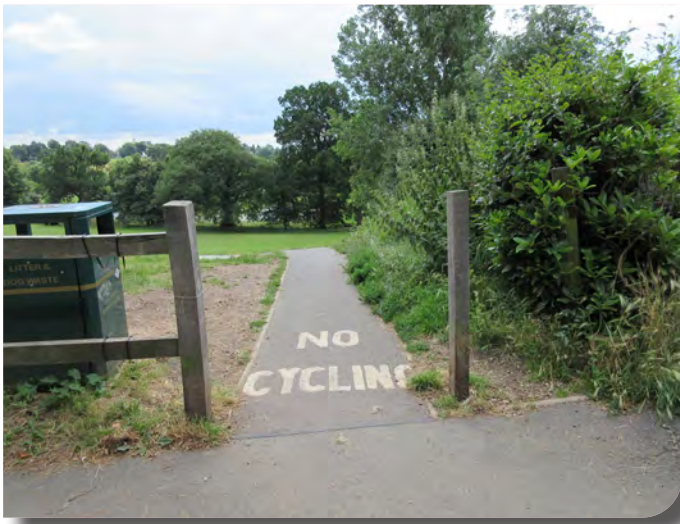
Access to northern bank is via two entrances off High Street. One entrance, a secondary historic entrance, has a double leaf gate with a trombone handle, a style that works well with the Fields and limits vehicle access with a removable, lockable bollard. The other entrance, a primary entrance, is open to pedestrians restricting vehicle access using a timber bollard/fence post.

Seating varies with a number of styles throughout and within proximity to this area. Benches in popular locations have substantial erosion and wear to their

base often making the seat height greater than the recommended height.

1. **Replace metal benches with timber benches in line with the Fields's design code. Ensure all existing timber benches are refurbished and that replacement is in line with the Field's design code.**
2. **Clean and maintain existing bin and locate within hard surfacing to reduce erosion. Ensure bin style is consistent with the Fields's design code.**
3. **Widen the primary entrance off High Street and ensure any bollards introduced are consistent with the Fields's design code.**
4. **Introduce Fields welcome sign to primary entrance in accordance with design code.**
5. **Introduce way markers for the Centenary Way long distance route. These could be incorporated into the welcome sign.**

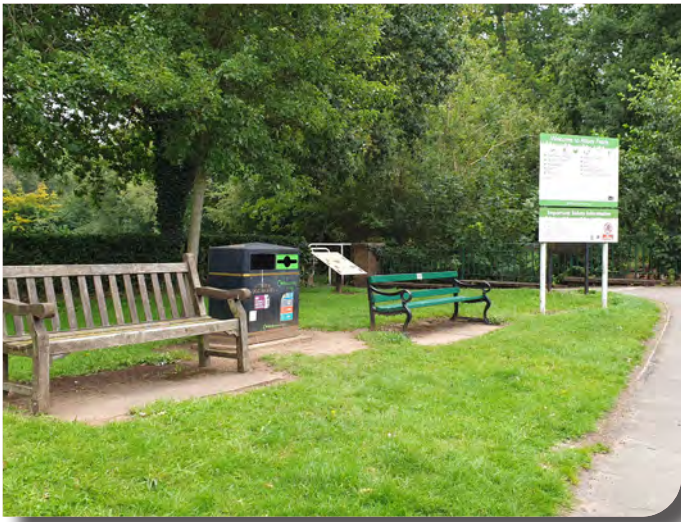
The entrance to the lake is cluttered with mismatching benches, and three entrance signs.

The welcome sign to Abbey Fields is too small, soiled and showing signs of wear. It is a welcome sign for pedestrians on a busy primary entrance, but also on a busy road with passing visitors to Kenilworth Castle. As a vehicle welcome sign, it faces only one way on Castle Road, and passing visitors to the castle or people driving past would not be able to read the sign as the typeface of cream on green disappears and the rest is too small to be read from a vehicle.

Two other signs located at this primary entrance compete for attention and clutter the main entrance. They are both soiled and damaged with rusty legs. The signs provide visitor information to historic sites within Abbey Fields and the wider area and both include maps. The information provided could be combined into one sign. There is much erosion to the base of both signs, so both are readily reviewed.

4. **Widen the entrance and replace the hooped chicane with a bollard entrance. Ensure any bollards introduced are consistent with the Fields's design code.**

6. **Provide a wildlife interpretation panel along the northern lake edge.**
7. **Regularly clean and maintain existing bins and locate within tarmac to reduce erosion. Replace bins and ensure the bin style is consistent with the Fields's design code.**

8. **Consistency of fencing throughout the Fields is of importance. Replace bow top fencing with estate style fencing. This should be painted a recessive black. Ensure any new fencing incorporated within the Leisure Facility is in accordance with the Fields's design code.**

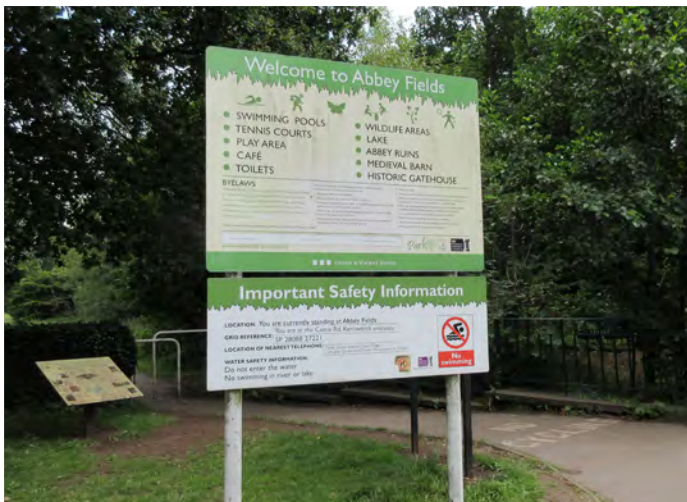
As a pedestrian sign the message becomes lost within the sign as it holds too much information and there is no map of the Fields. However, there is substantial information about 'What not to do' i.e. byelaws and safety information that any positive message of what you can do is lost. Its location as an information welcome sign is also outside of the Fields boundary and context is lost.

1. **Change the welcome sign to the Fields and have a large sign to face Castle Road. This should be consistent with the entrance sign at the main car park entrance.**

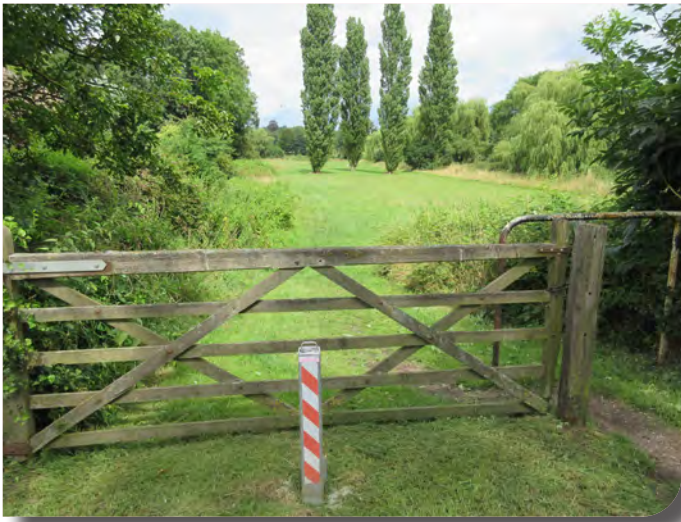
The entrances to south brook include a kissing gate off Castle Road, and a hooped barrier off Borrowell Lane. The kissing gate is in good order but provides a pinch point to the Fields with extensive erosion. The hooped barrier is in a poor state of repair with flaking paint and is a pedestrian unfriendly access. Adjoining it is a maintenance access field with gate and posts showing signs of deterioration.

Two timber bridges form important connections across Luzley Brook. They both appear to be in good condition, although would require regular inspection by a structural engineer to look for signs of deterioration.

Post and 2 rail fences are used around the Fields to control movement and in most instances is in good condition. At the kissing gate as seen above, the fence is post and 3 rail creating greater height.

Seating in this part of the Fields is mostly timber benches with one traditional metal bench set in slabs at the transition between this zone and Hillside. There is substantial erosion around the timber benches set within earth. The benches are showing signs of wear. Paint is also damaged on the traditional bench.

2. **Replace the kissing gate with a bollard entrance, ensuring all bollards used are in line with the Fields's design code.**
3. **Replace the secondary entrance at Borrowell Lane with a double leaf field gate with trombone latch similar to secondary access on High Street.**

6. **Refurbish or replace existing timber benches in line with the Fields's design code. Refurbish metal bench in line with design code.**
7. **Site all benches in hard standing, subject to Historic England approval and connect to the main path network to reduce erosion.**

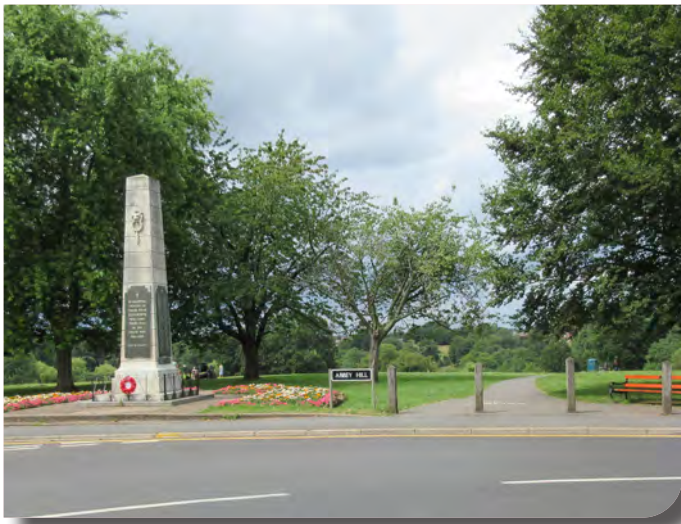
Pedestrian entrances to Hillside include timber bollards, although of varying styles, size and condition. Most are in good condition.

Maintenance vehicles access Hillside via a number of field gates with lockable removable bollards. All field gates appear in good condition.

There are a number of bins located within and to the immediate outskirts of this zone. Each bin is different and there is no consistency throughout this area. The bins are all soiled and dated in style. The dog bin and recycling bin look very well used.

5. **All benches to be traditional metal style. These should all be painted a uniform consistent dark colour. Orange colours to be phased out. Refurbish historic bench to a high standard. All benches to be regularly cleaned.**

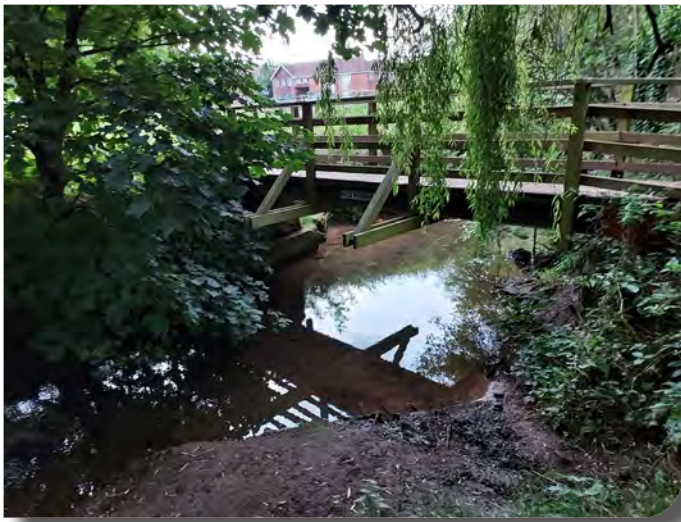
A timber constructed bridge traverses Finham Brook into the Play and Leisure zone. It is a narrow bridge but appears in good condition. It takes a large volume of footfall as the erosion is extensive on the approaches either side.

6. **Potential to widen the bridge over Finham Brook.**
7. **Regularly inspect the bridge to ensure it remains safe and serviceable.**
8. **Repair and paint the bus shelters.**

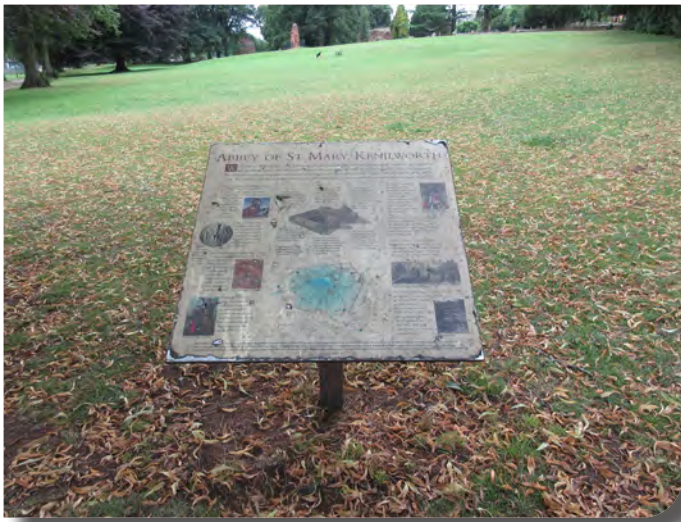
There are a number of signs located around the Play and Leisure area. A sign detailing the history of the site is located at the entrance to the Main Drive and is set under trees. It is suffering degradation, is heavily soiled, with cracks and damage. There is much wear to the base of the signage showing its popularity despite its condition.

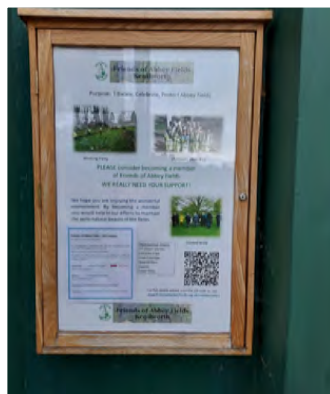
A second News and Events board is located on the Leisure Centre building but is showing signs of significant weather damage and wear. The information within it is haphazard and covers mainly 'what not to do' within the Fields. Any news of interest is lost as a result. The Friends of Abbey Fields have a separate noticeboard to the news and events board. That noticeboard is smaller than the main news and events board. This additional noticeboard is confusing and undermines the purpose of the larger notice board.

1. Have Welcome signs to the Fields entrances that provide a Fields map, information, do's and create a positive welcoming feel to Abbey Fields.
2. News and events board to contain only information pertinent to news and events and not on rules and regulations of the Fields. The information needs to be much bolder and clearer to read. Refresh printing regularly where it fades in sunlight. Combine the Friends of the Fields noticeboard into the main news board.

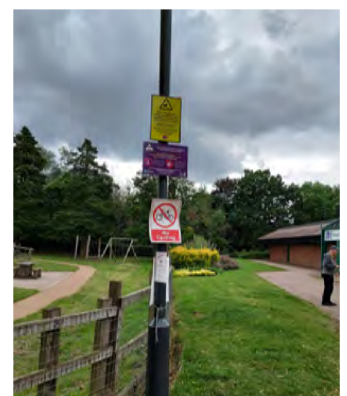
Smaller informative signs are located on lampposts around this zone. Their information varies and create masses of confusing clutter that are generally missed and not read.

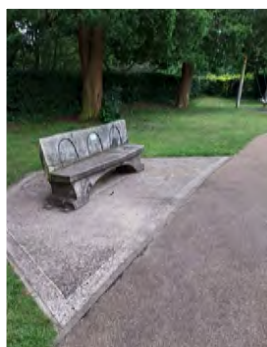
Seating within the fenced play enclosure includes picnic benches, but also a whole range of styles some playful and characterful. However, many of the standard benches within the meadow have substantial deterioration and need repair or replacement. There is excessive concrete bases to the playful benches in the play area which detract from the quality of the area.

9. Replace all picnic benches and ensure they are on erosion mats (allowing for establishment time) to reduce surface wear. Provide a number of accessible picnic benches for wheelchair users adjacent to existing paths (potentially located within Church & Abbey zone). Picnic benches to be in accordance with the Fields's design code.

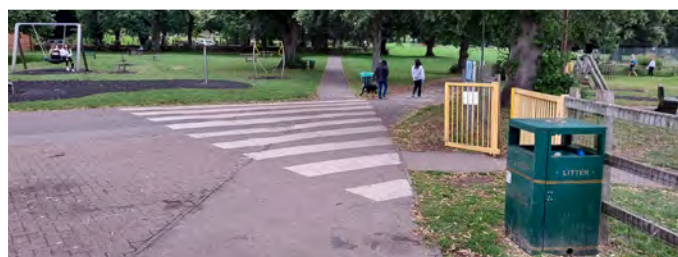
Bins vary in style and condition. There are a number of open topped bins located in the area. They are dated, soiled and often rusty. There is much erosion to their base. The bins adjacent to the play area entrance are soiled, but well used and in reasonable condition. The recycling bin is tucked under the eaves of the Leisure Facility near to the outdoor kiosk. It is heavily soiled and unpleasant to use. There are no bins within the fenced play area and litter is notably increased in this area.

6. Bollards and bins to be all of one style throughout the Fields and all bins to be kept clean.
7. Fingerposts to be located in visible pedestrian locations and be of a modern style but not stainless or brushed steel as this is not the character of the Fields. Ensure they direct to Fields facilities as well as historic reference points. Finger posts to be located within the centre of the Fields.

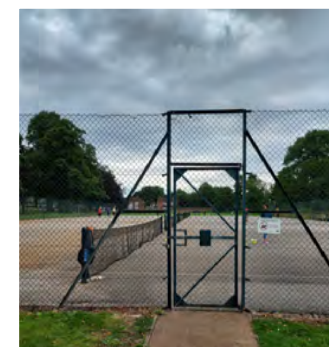
The tennis courts fencing is a chain link fence and is showing signs of age and wear. It is a dated form of enclosure for tennis courts and posts are bending and beginning to fail.

12. Refurbish the tennis courts and replace all fencing.
13. Repair or replace broken or rotten play equipment (including 'mole' within the meadow') to encourage positive engagement with the play space. Broken and damaged play equipment may encourage antisocial behaviour.

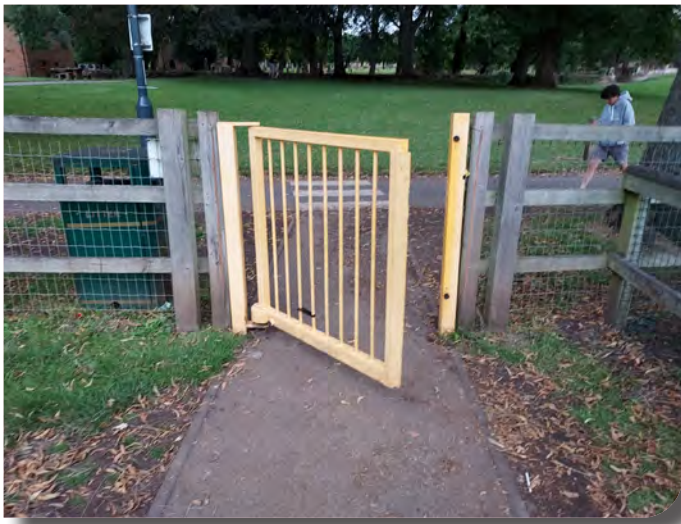
Barriers at Bridge Street are used to direct the movement of pedestrians. Barriers are also located at the historic iron bridge over Finham Brook which is narrow and a severe pinch point at the Leisure Facility.

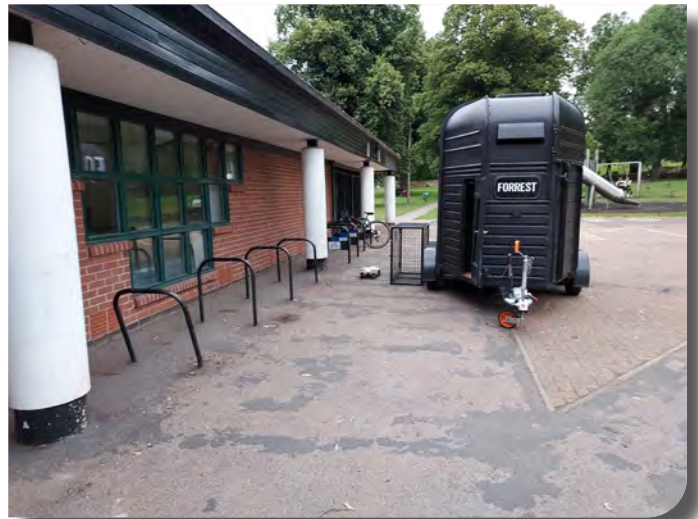
Cycle parking at the Leisure Centre is located underneath the overhang of the roof. Some of the cycle hoops are bent and damaged. Replacement cycle provision is likely to be included in the Leisure Centre development.

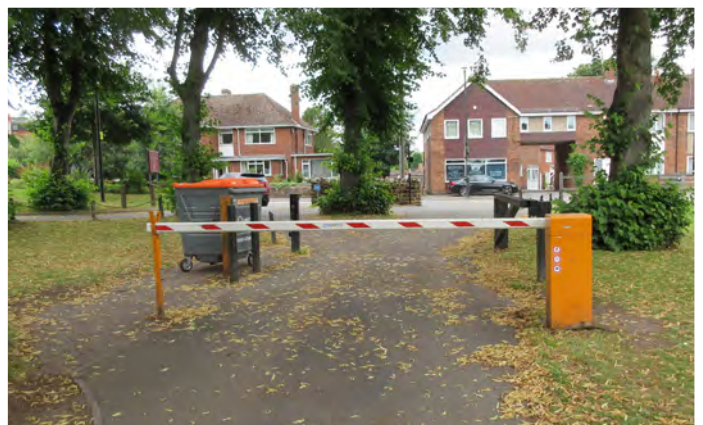
Access along Main Drive is through a utilitarian style barrier, with additional lockable 'A' frame gate. The barrier jars with the style of the Fields and provides an unattractive focal point.

18. Consider alternative vehicle access to Main Drive to replace the barrier to improve pedestrian permeability.
