# CHAPEL OF ST MICHAEL & THE MASTERS HOUSE

Saltisford, Warwick, Warwickshire

## Heritage Impact Assessment

Document No: TJC2020.79

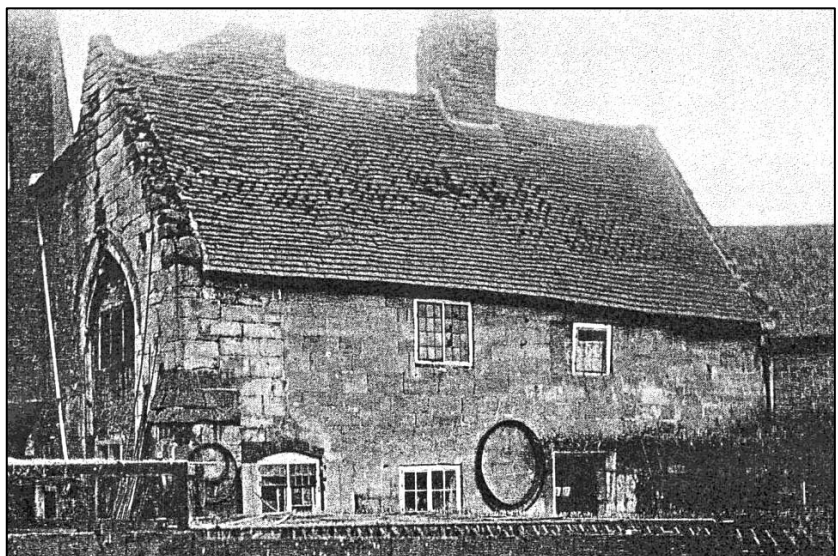
**Appendix 2.3:**

Exterior of chapel c.1880s

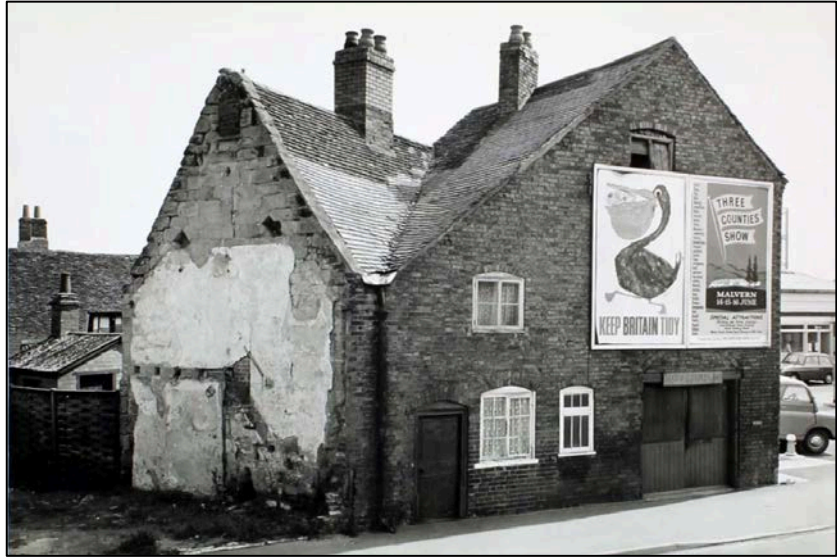
**Appendix 2.4:**

Exterior of chapel prior to  
demolition of smithy looking  
north-east

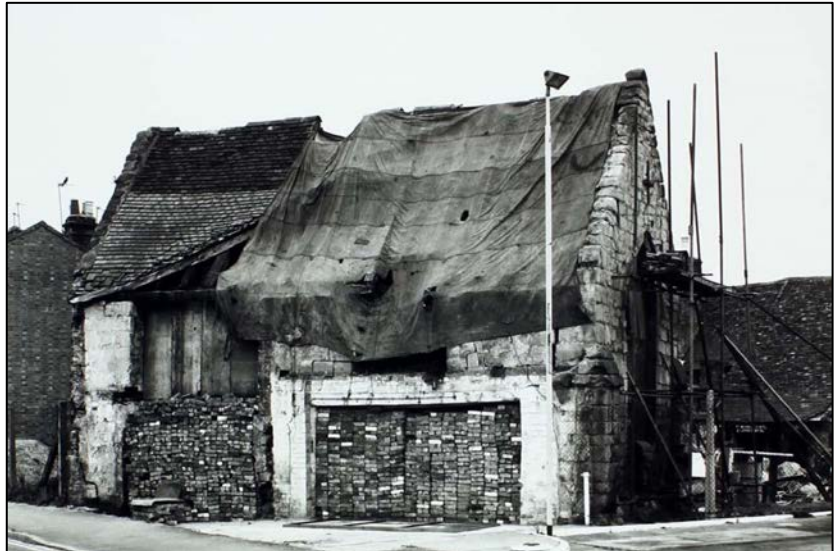
**Appendix 2.5:**

Exterior of chapel following  
demolition of smithy looking  
north

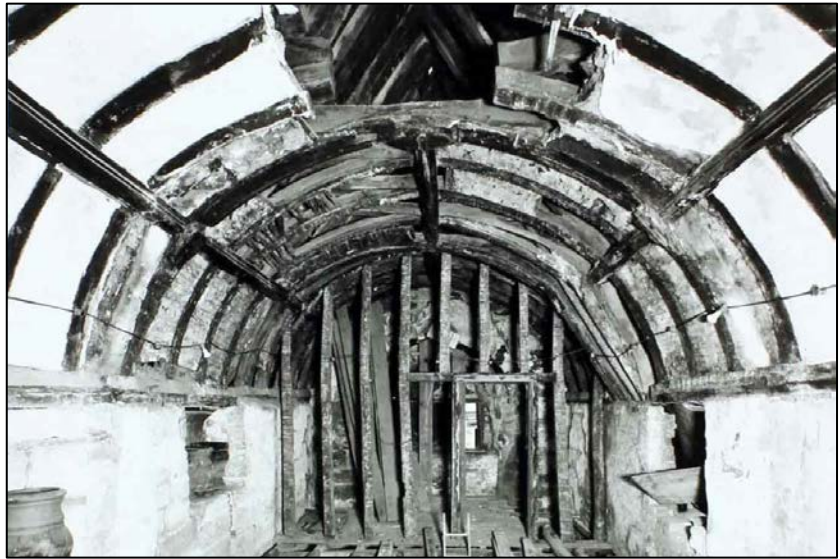
**Appendix 2.10:**

Detail of vaulted ceiling  
inside chapel, looking east  
HE Archive 6090/8 31.10.78

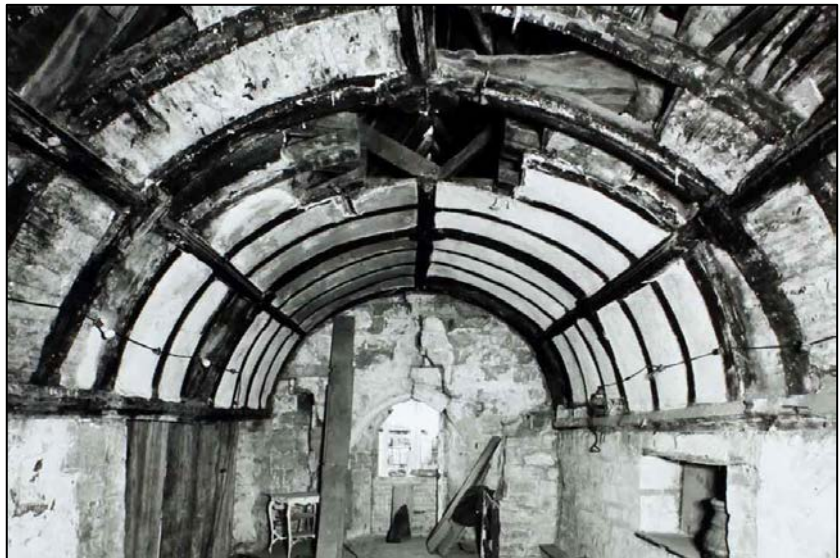
**Appendix 2.11:**

Detail of vaulted ceiling  
inside chapel, looking west  
HE Archive 6090/7 31.10.78

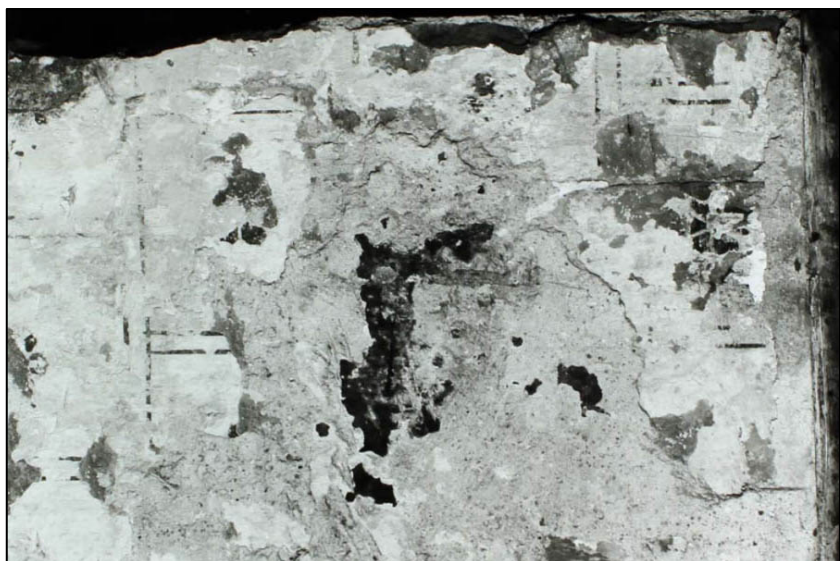
**Appendix 2.12:**

Detail of painted wallplaster  
inside chapel  
HE Archive 6090/11  
31.10.78

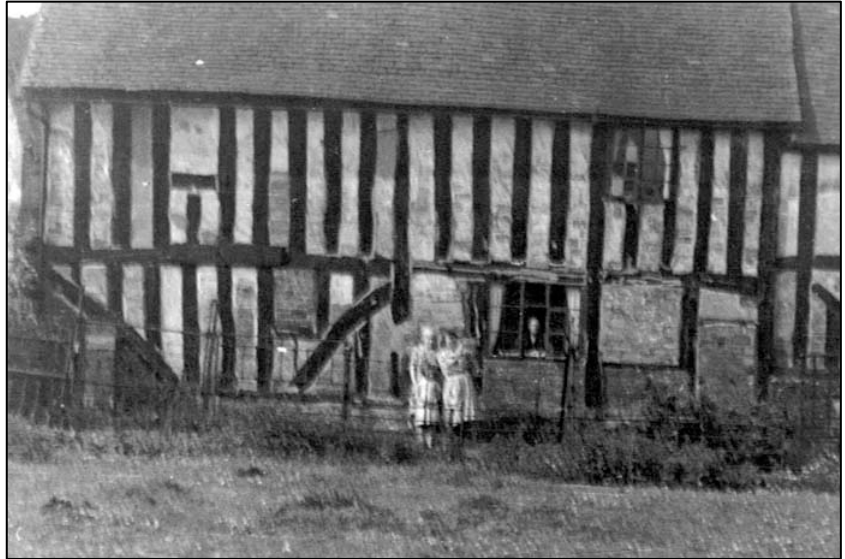
**Appendix 3.13:**

External view of the north  
elevation of the Master's  
House (c.1950s)

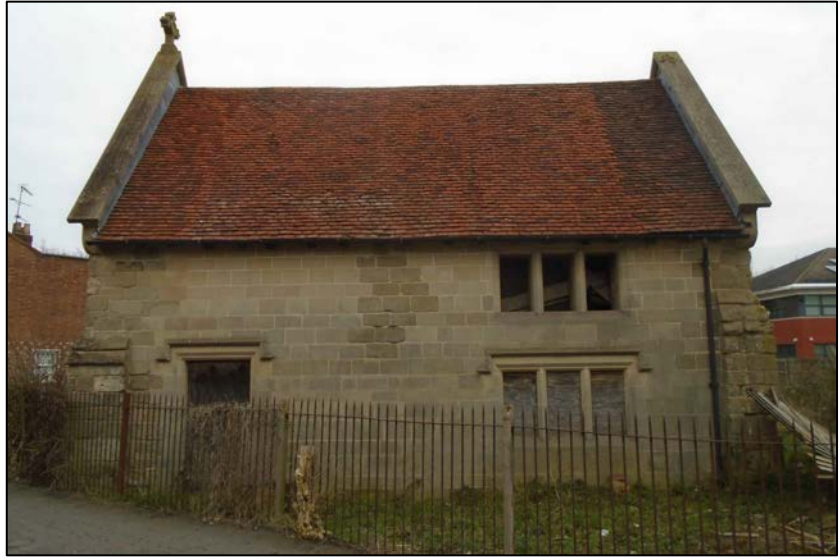
**Appendix 4.4:**

Detail of south elevation of  
the Chapel, c.2020

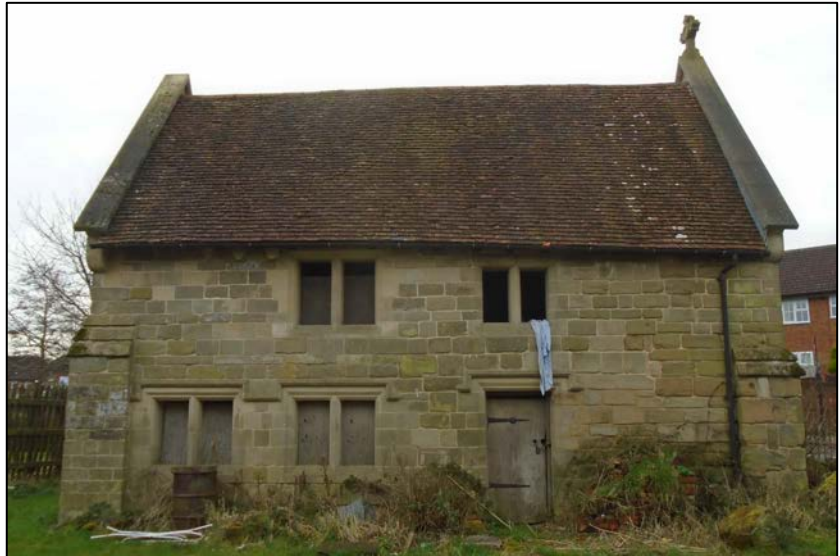
**Appendix 4.5:**

Detail of north elevation of  
the Chapel, c.2020

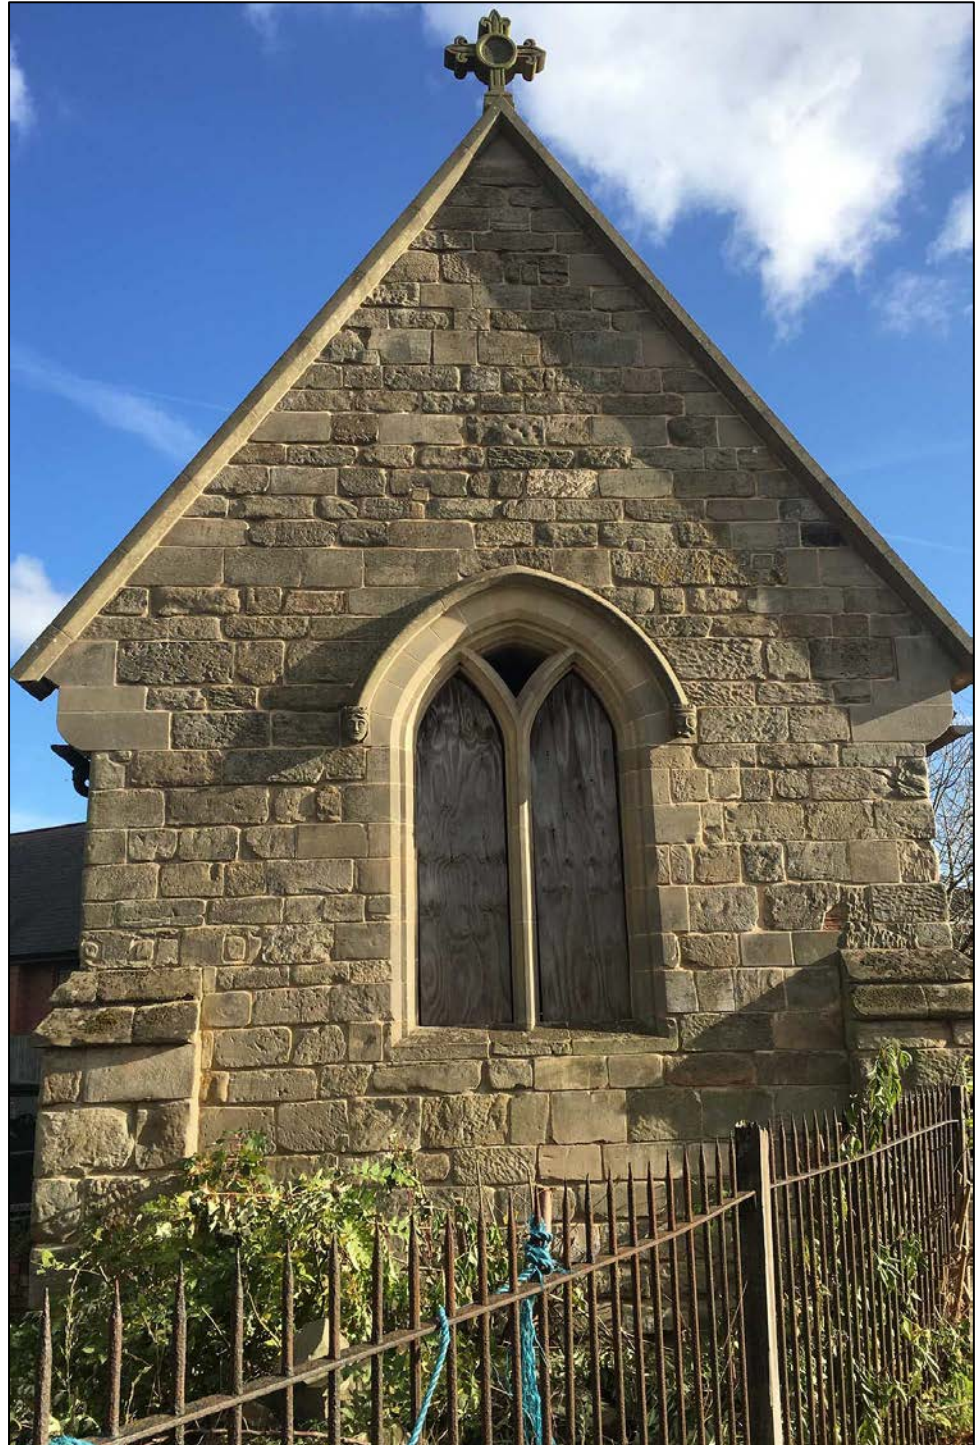
**Appendix 4.7:**

Detail of west  
gable of the  
Chapel, c.2020

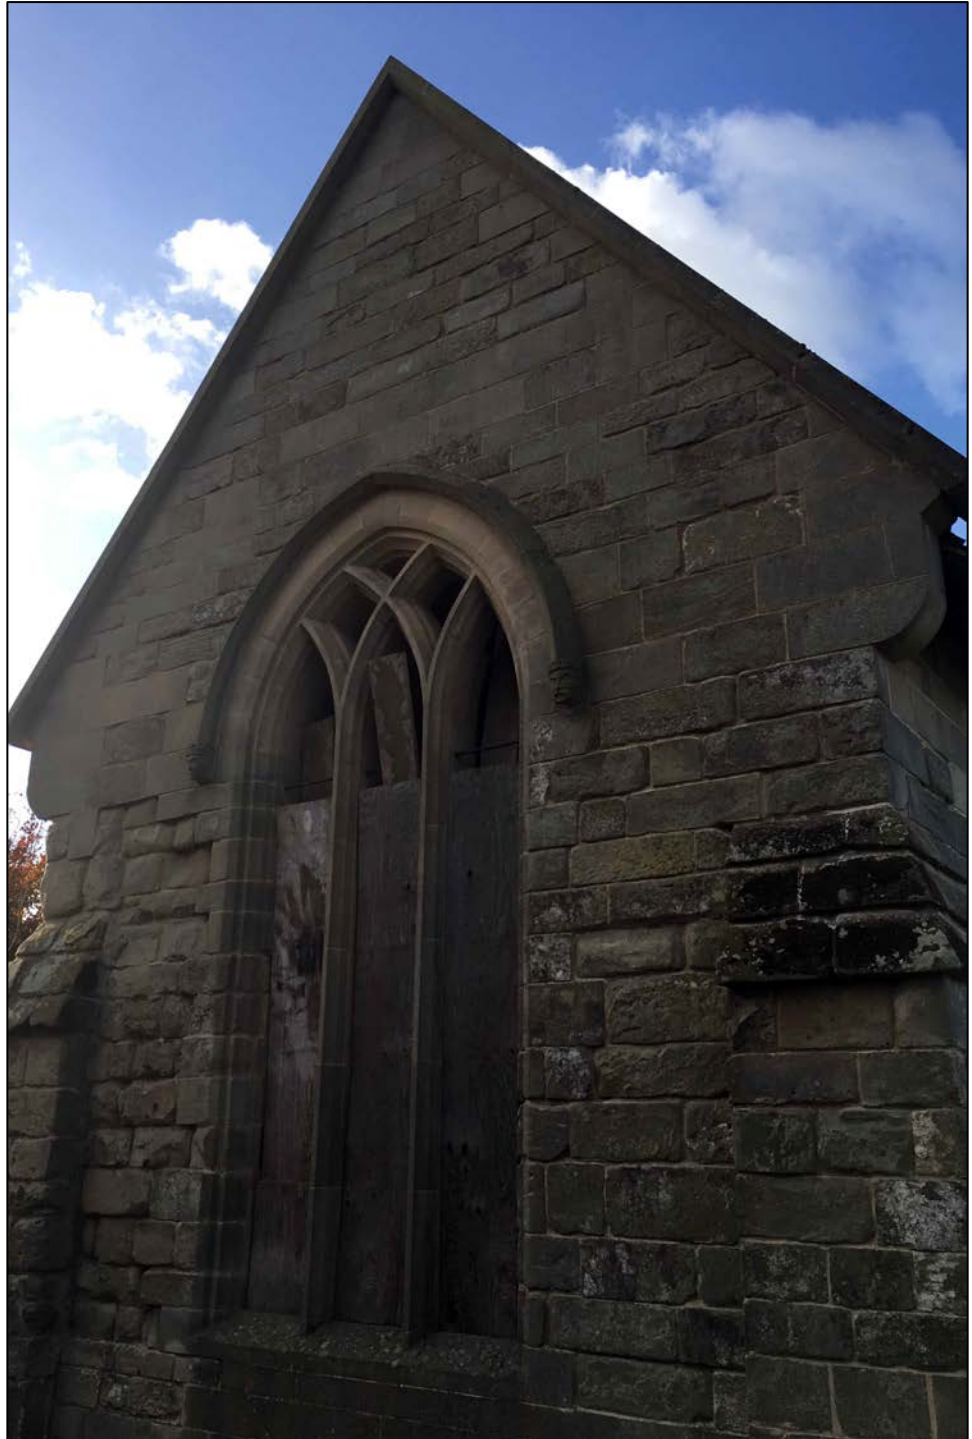
**Appendix 4.8:**

Detail of east  
gable of the  
Chapel, c.2020

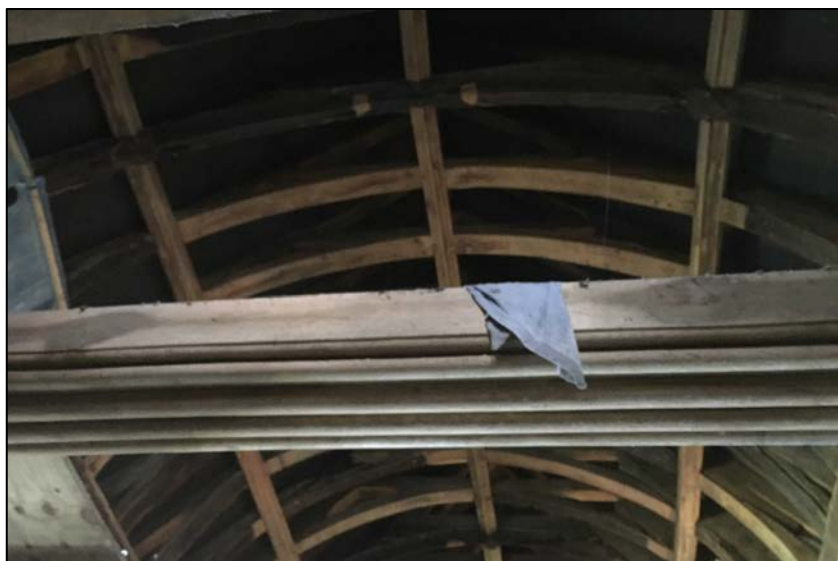
**Appendix 4.11:**

View of the roof inside the Chapel, c.2020
